# Inspection Report

**A Plus House Inspection**

Report/Agreement # 061022095962

Inspection Date: 06 Oct 2022

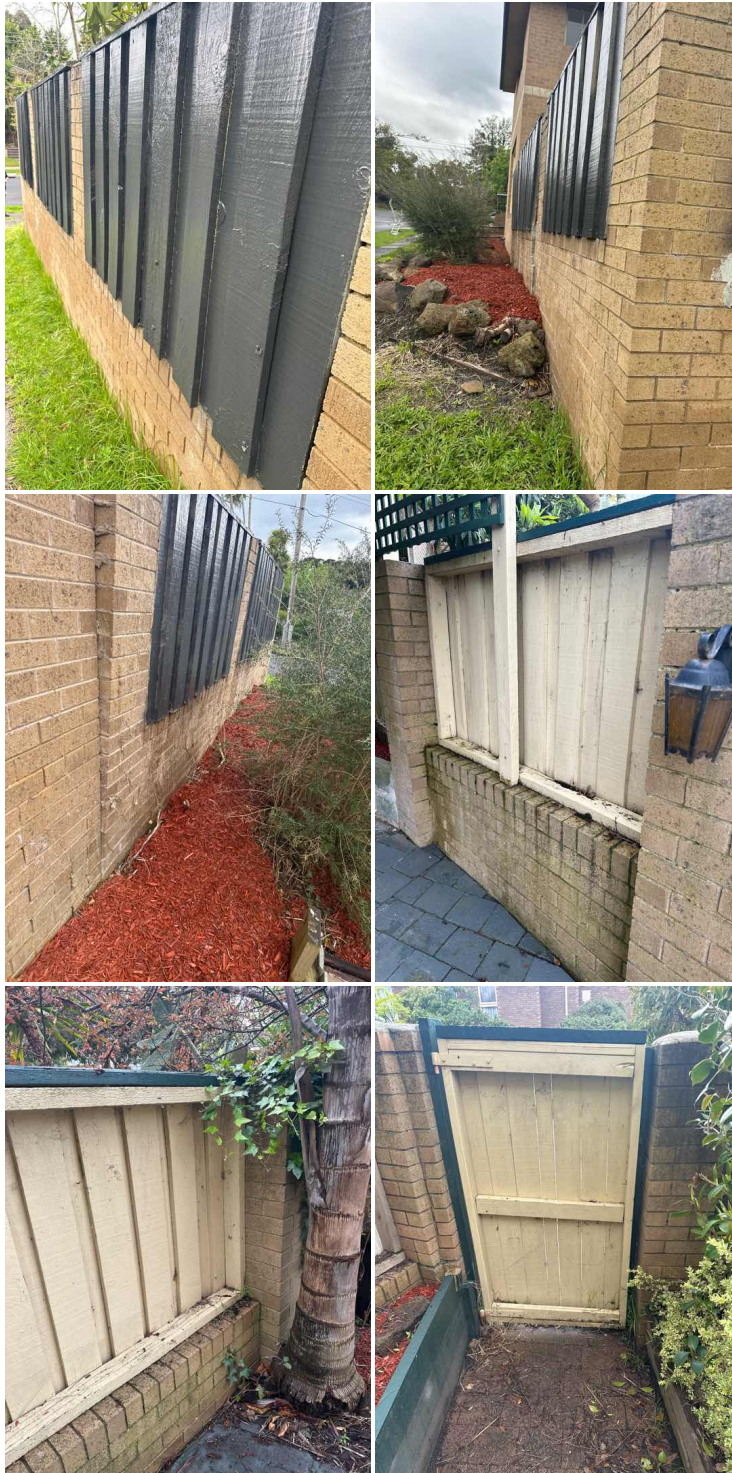
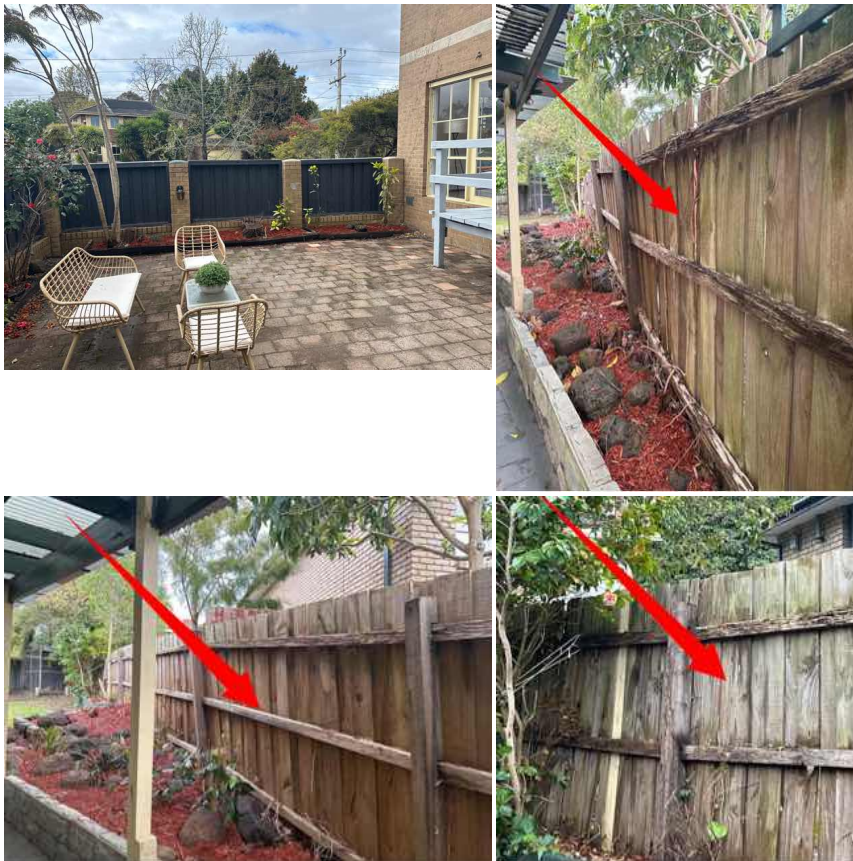
Fence rot/leaning. Repairs are required by a fencing contractor to avoid unsafe conditions.

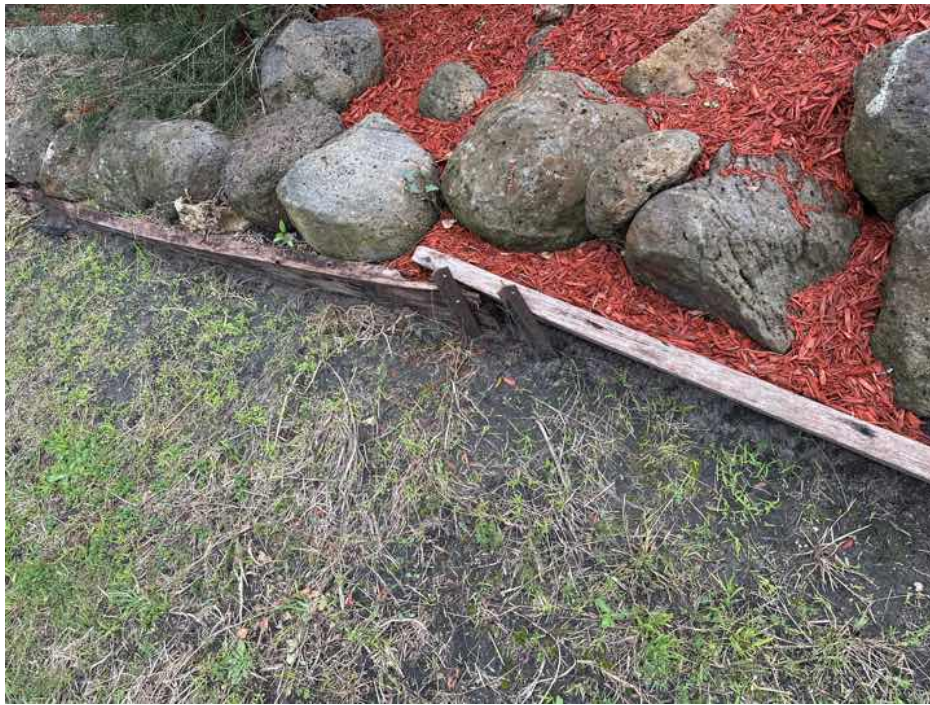
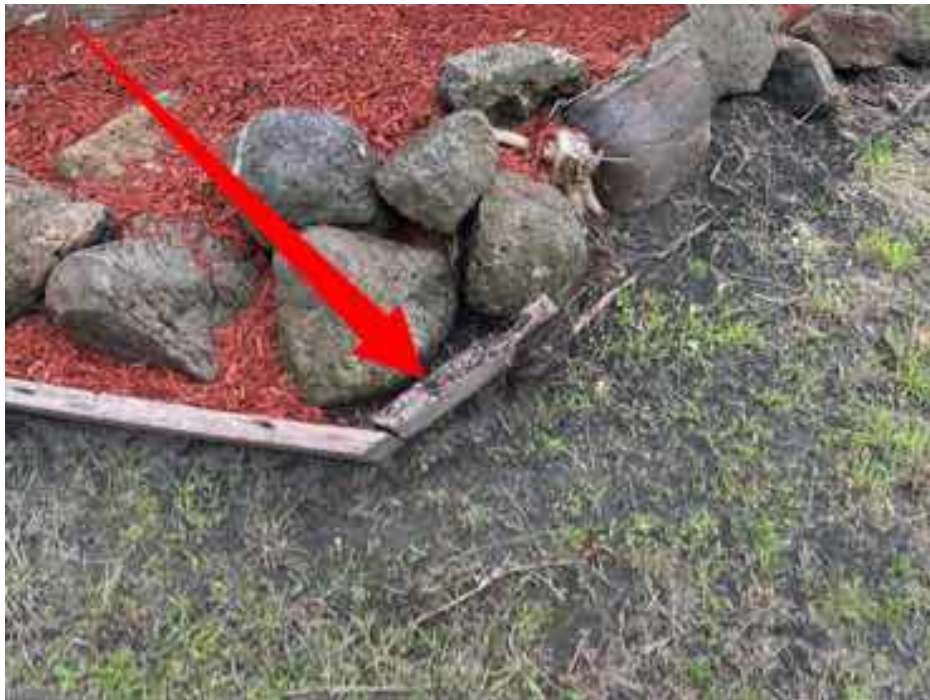
Retaining wall leaning due to deterioration and age. A qualified brick layer should be engaged for advice and recommendations.

Timber fungal decay evident. Recommendations: A qualified landscaping contractor should be engaged for repairs and recommendations.

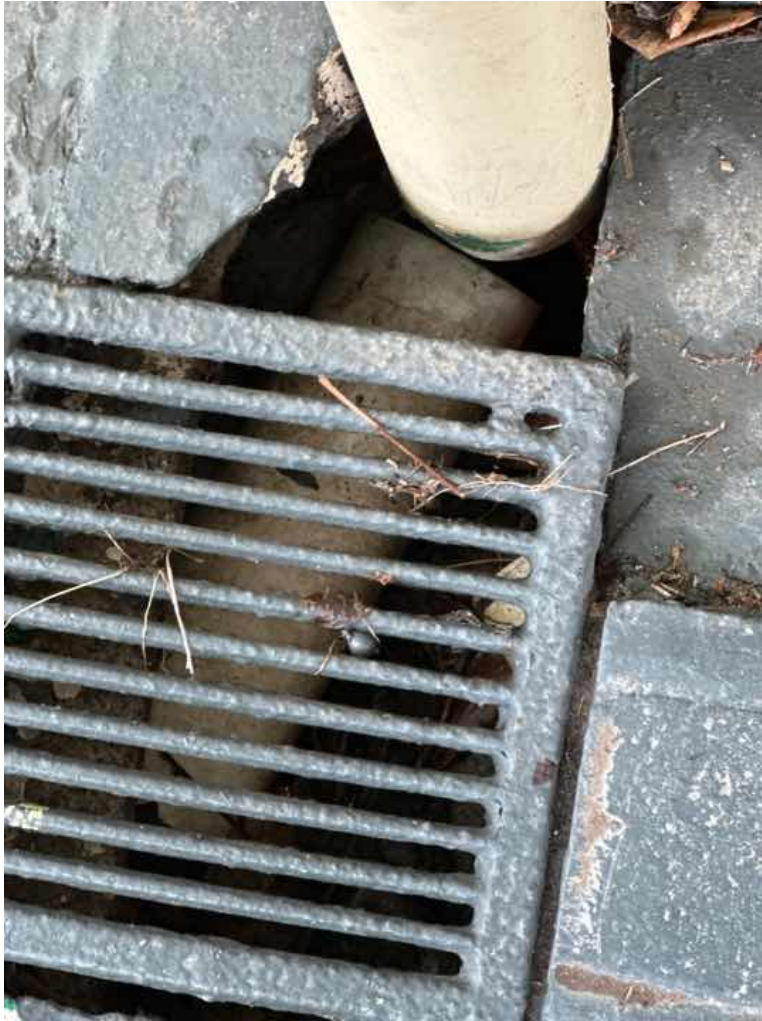
Not connected

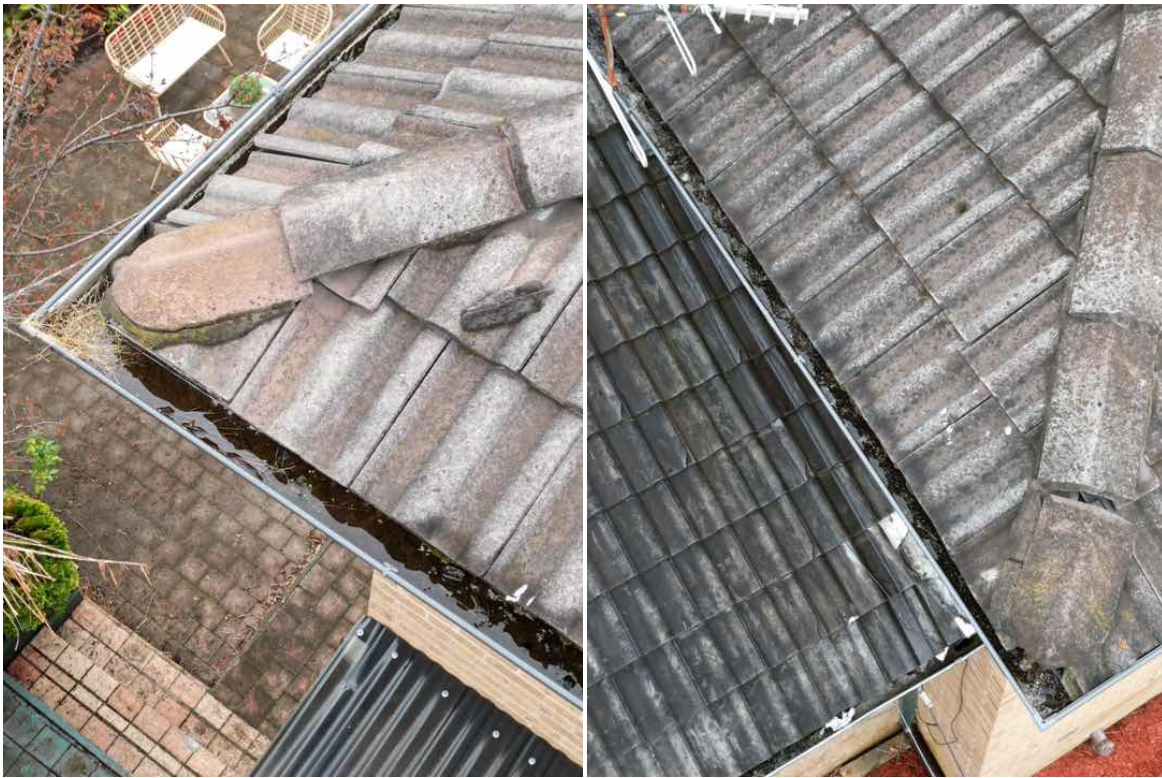
Tile lift/unevenness visible - Recommendations: Have roofer re-fix. Considered a minor defect but has the potential to become a Major defect if repairs aren't carried out immediately due to water ingress into the roof cavity.

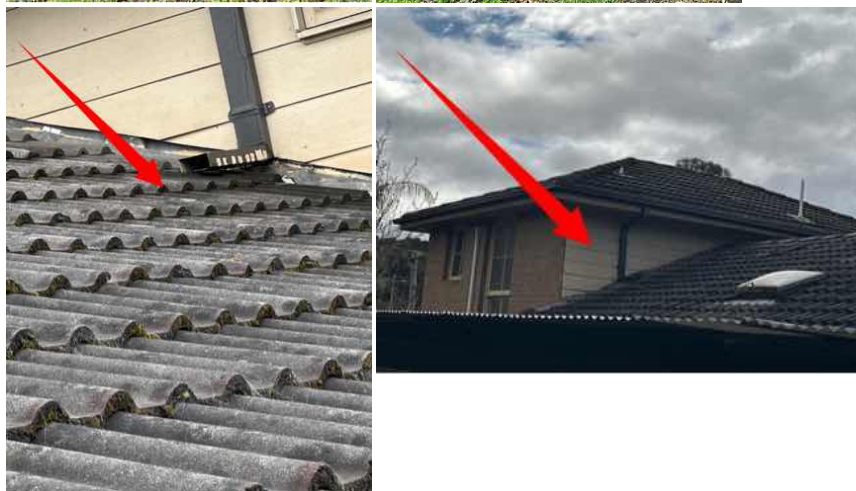
Leaking downpipe joints visible. This can be conducive to termite infestation and cause water damage to cladding over time. A qualified roof plumber should be engaged to repair.

Downpipe/s not connected to storm water discharge - Downpipes not connected to storm water have the potential to cause differential settlement to the footings, cause rising damp and is also conducive to termite infestation. A qualified roof plumber should be engaged for advice and recommendations.

Spreado not installed

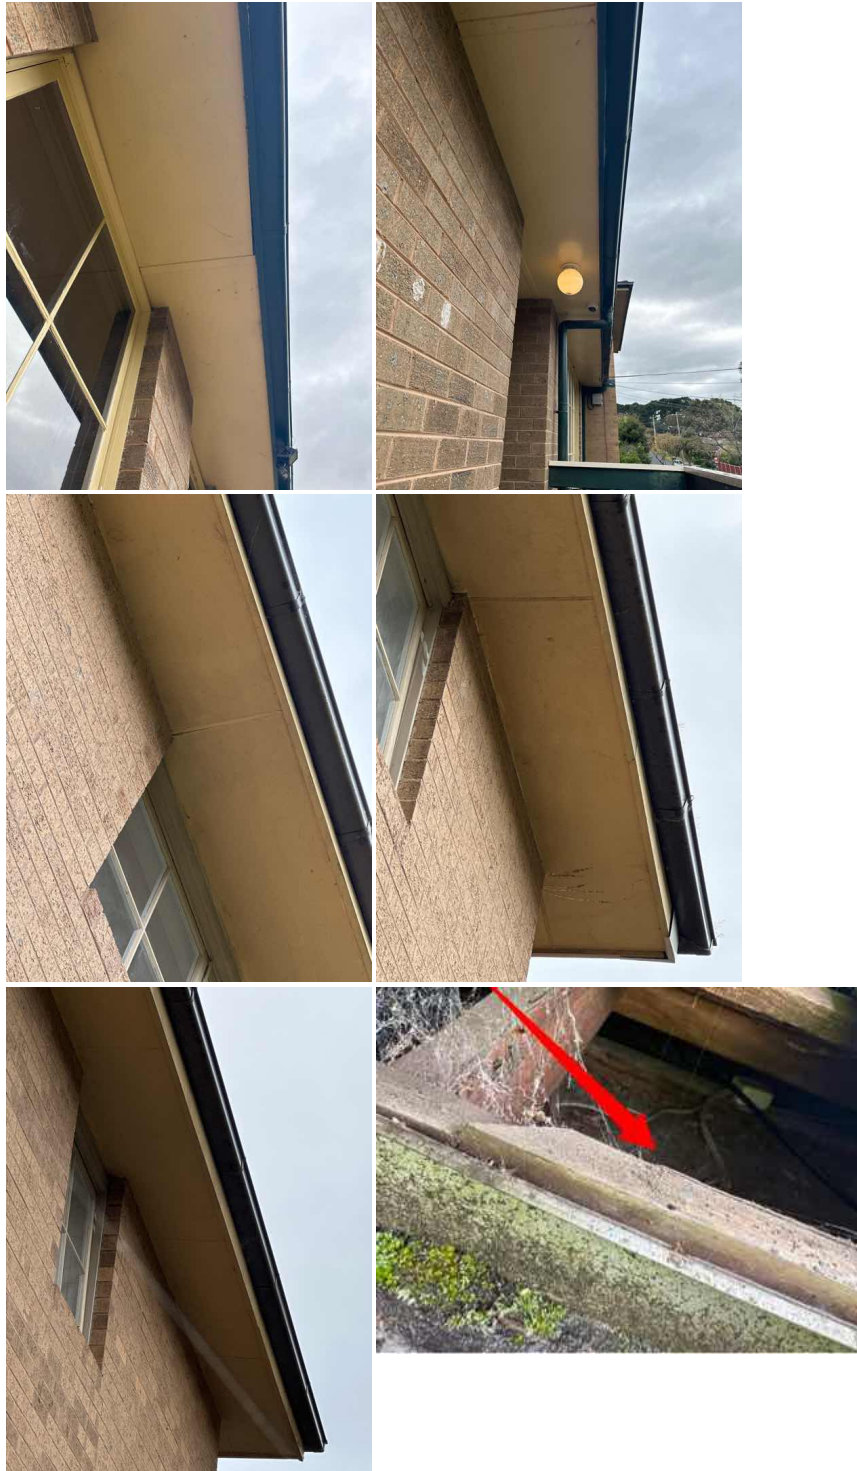
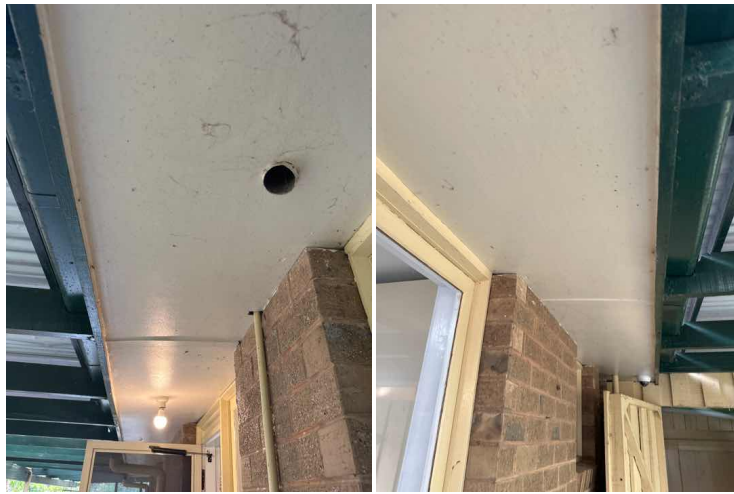
The soffit lining (eaves) are in a serviceable condition with no notable defects.  
Fibrous Cement Sheeting cladding sections. We recommend an ASBESTOS Inspection be conducted by a licensed Asbestos Inspector prior to a decision to purchase. Considered a Safety Hazard

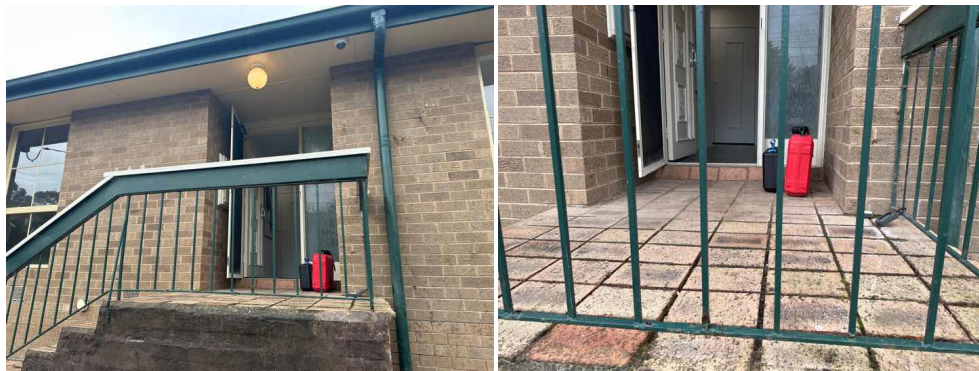
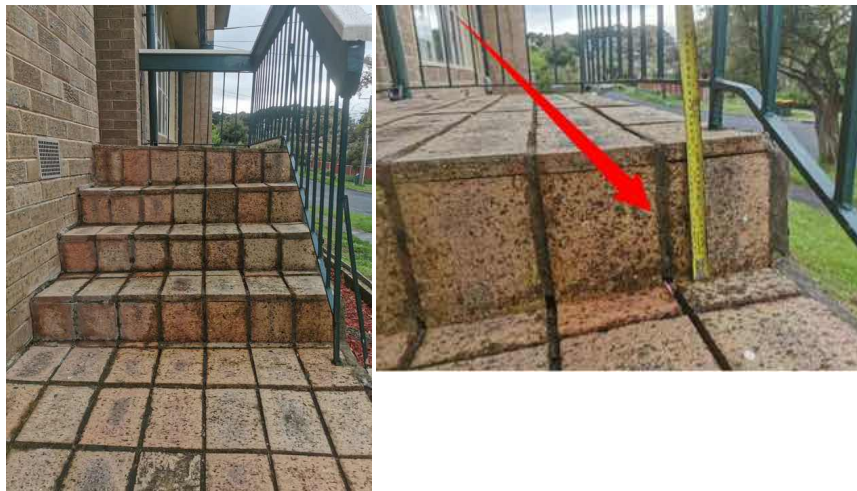
The entry porch serviceable or in reasonable or condition for the age of this dwelling.  
The stair not compliance

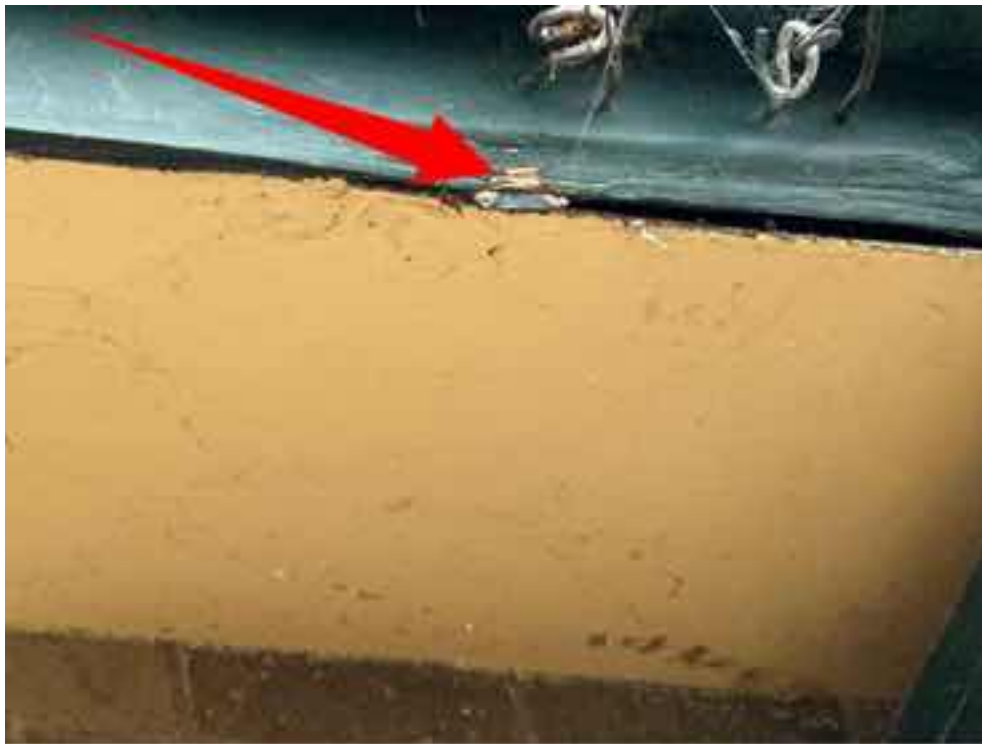
Timber fungal decay (rot) visible. Recommendations: A qualified carpenter should be engaged to replace all affected timbers.

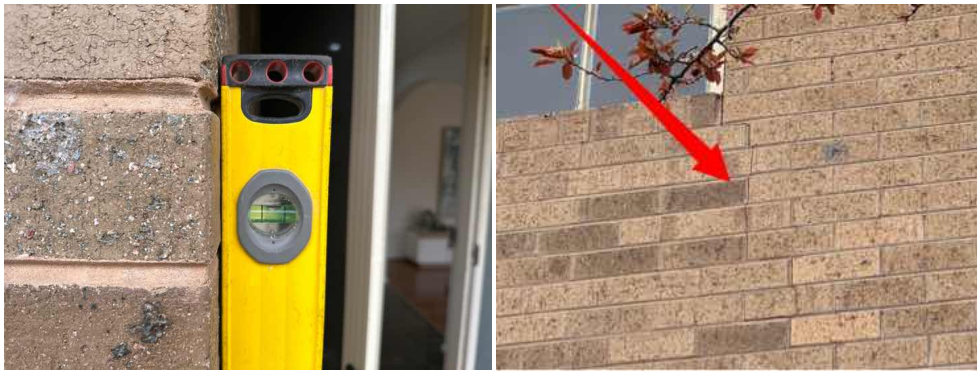
There appears to have been some settlement in the building which has caused some cracking to the walls. These cracks are categorized as 0 to 2. This can also cause some doors to bind or be out of square. In the inspectors opinion these cracks are due to settlement, usually due to ground movement and subsequent movement to building materials can be expected. Any cracks should be monitored and if cracks increase in size, further investigation should be carried out by a structural engineer.

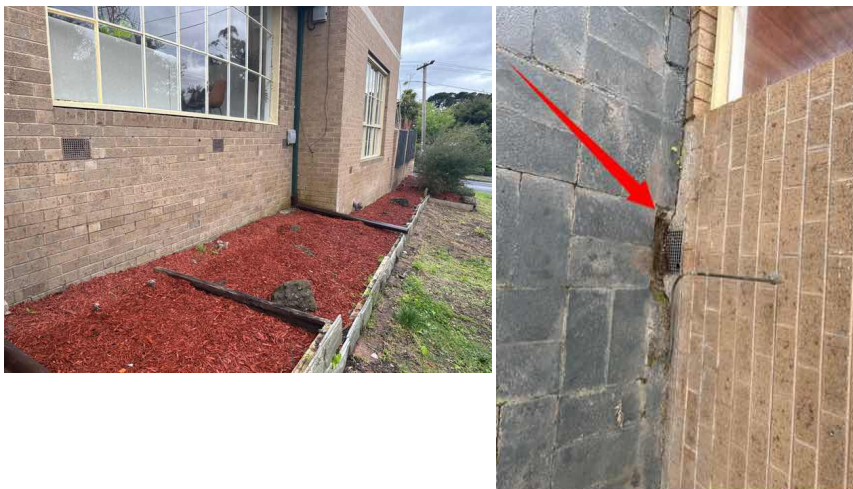
Vents are covered by soil/vegetation or have debris restricting ventilation to the sub floor Recommendations: Remove vegetation and or lower soil levels so that sub floor vents are unobstructed and allowing free flowing air.

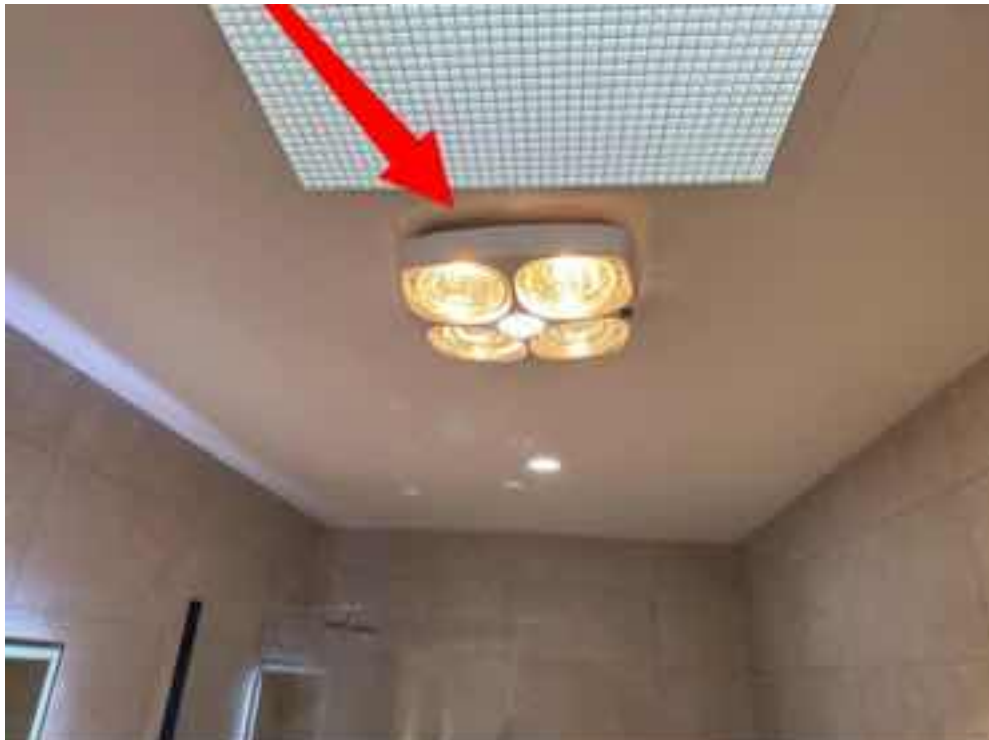
The bath heater not installed properly

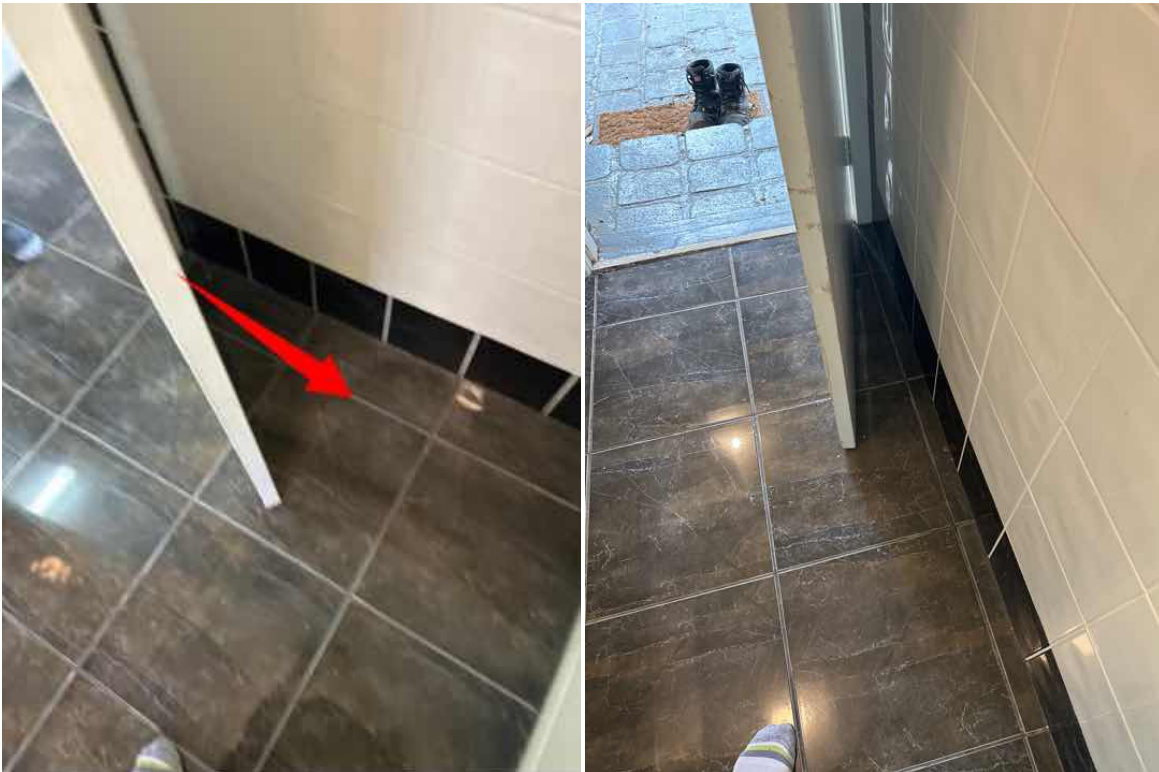
Door stop should be fitted - Wall damage from door handle impacting wall lining has occurred or is likely to occur. A qualified painter should be engaged for advice and recommendations.

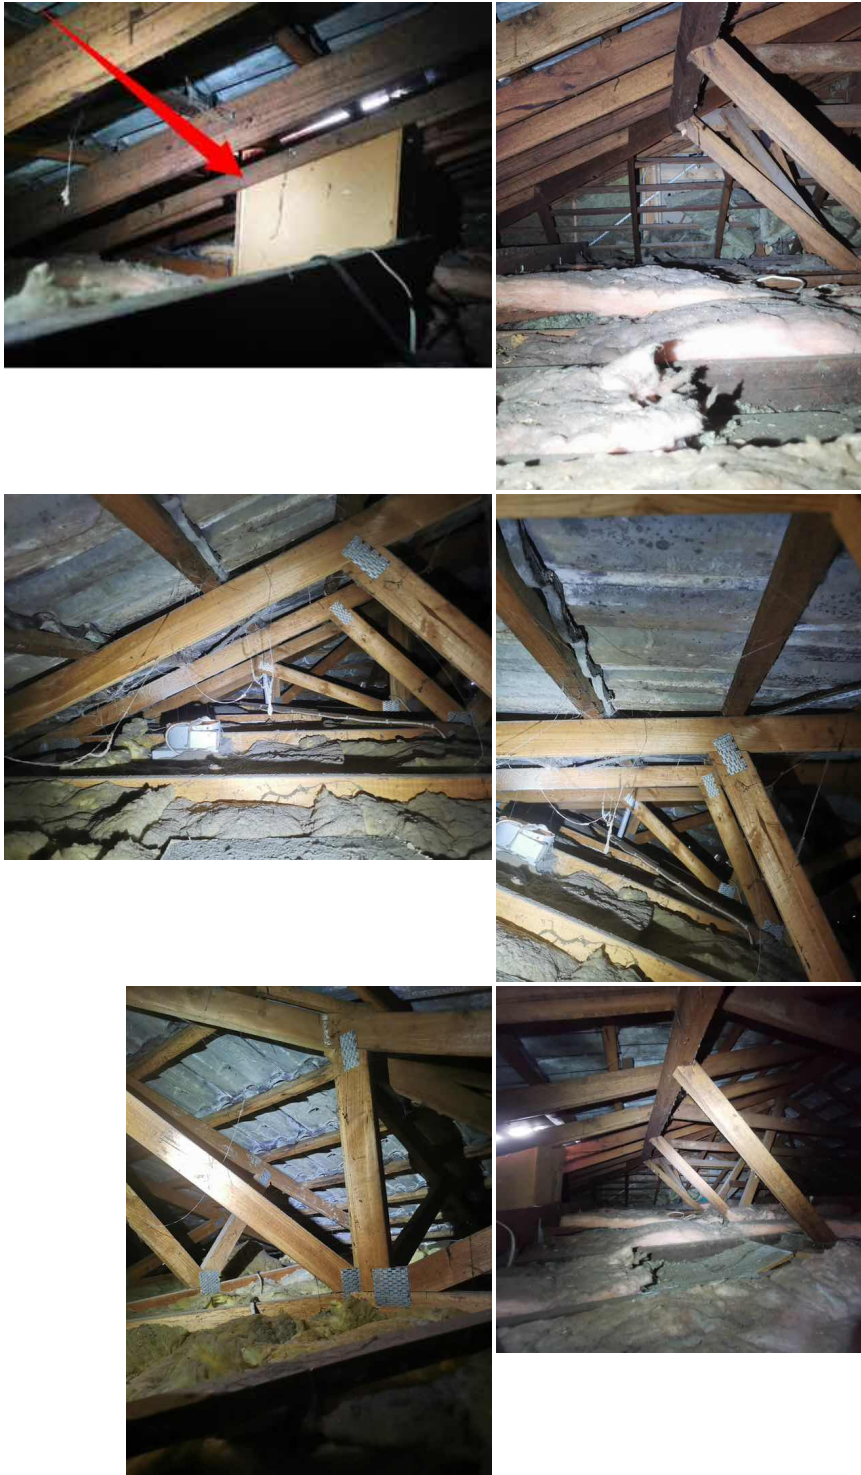
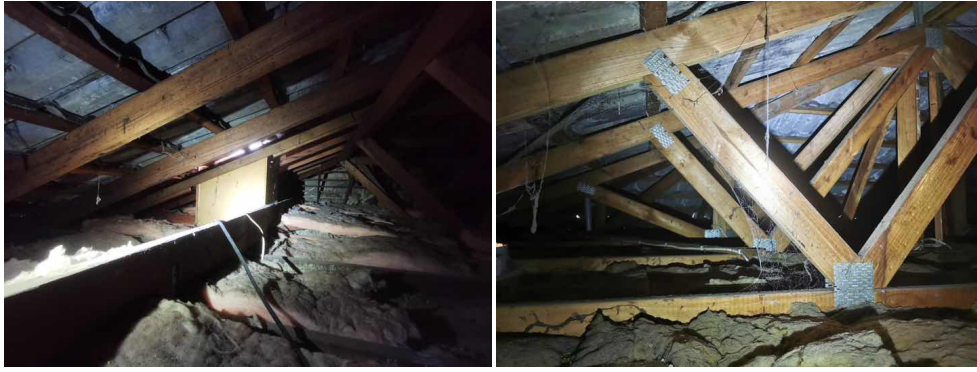
The rafter/split damaged. We recommend you engage a qualified roofing carpenter for further evaluation and advice.

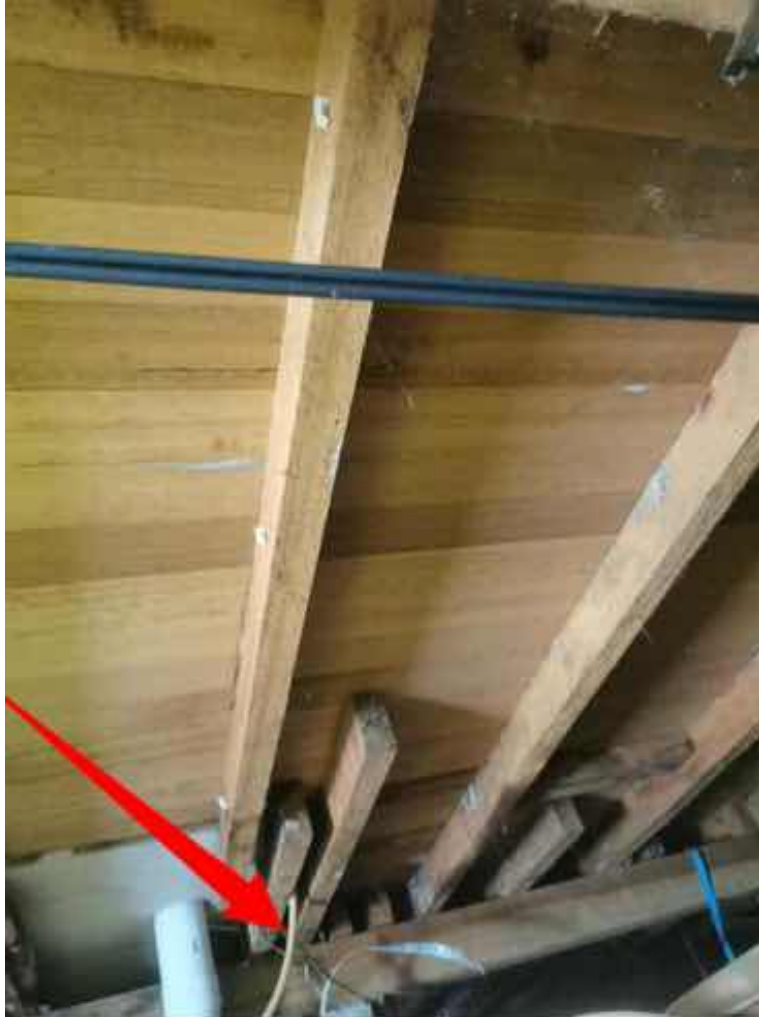
The joist broken.
