# Inspection Report

**A Plus House Inspection**

Report/Agreement # 061022095962

Inspection Date: 06 Oct 2022

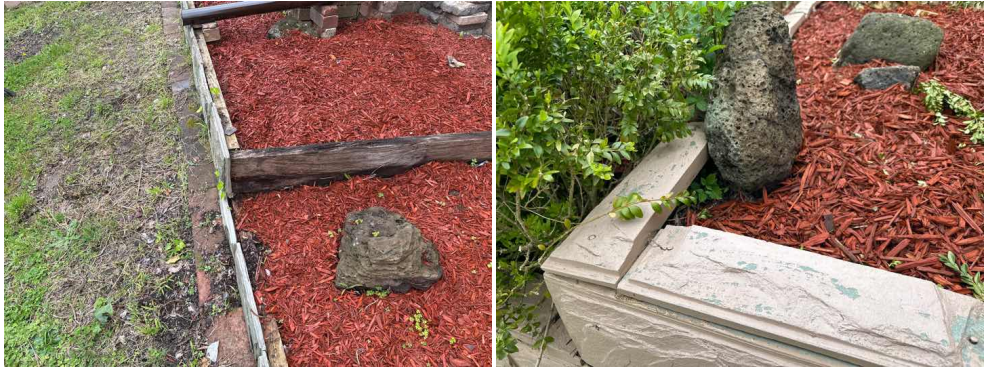
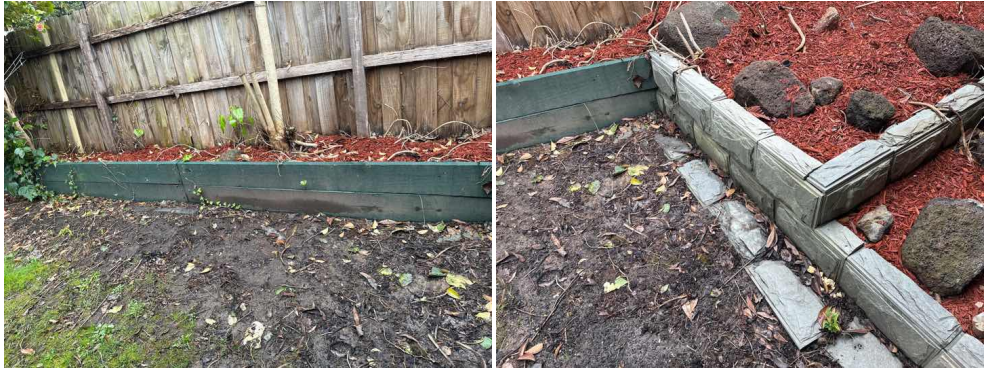
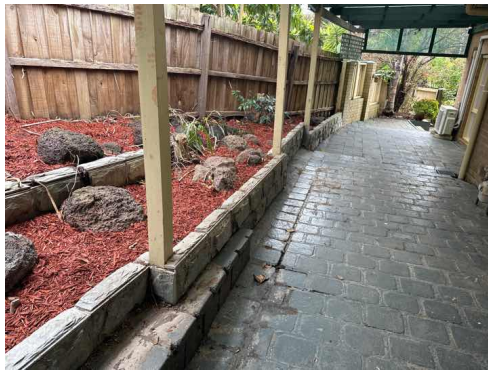
Retaining wall leaning due to deterioration and age. A qualified brick layer should be engaged for advice and recommendations.

Timber fungal decay evident. Recommendations: A qualified landscaping contractor should be engaged for repairs and recommendations.

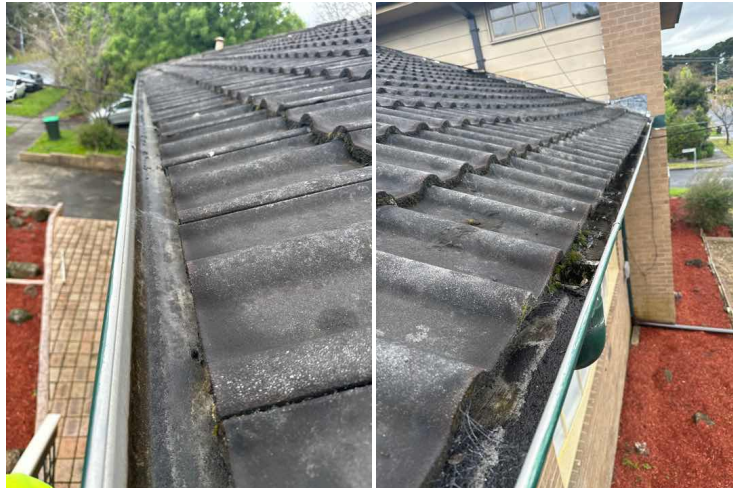
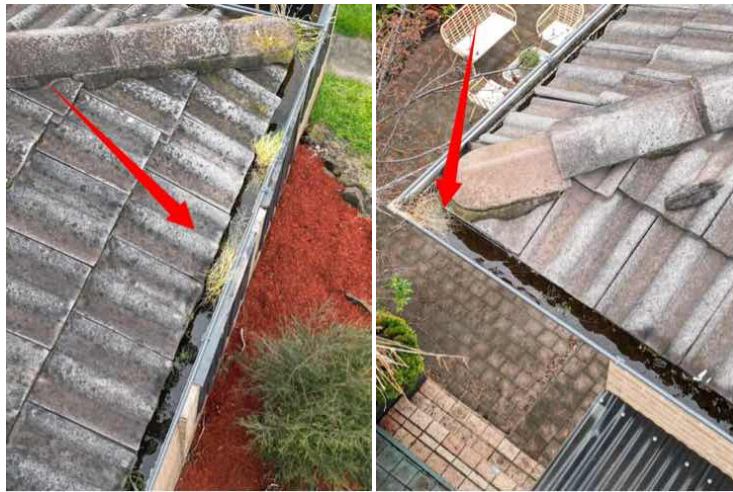
Debris in guttering areas- this requires cleaning out to prevent blocking of downpipes and leaking into eaves and fascia. Have gutters cleaned and assessed by a plumber for adequate fall. Regularly clean to prevent ponding. Ponding water will contribute to rust.

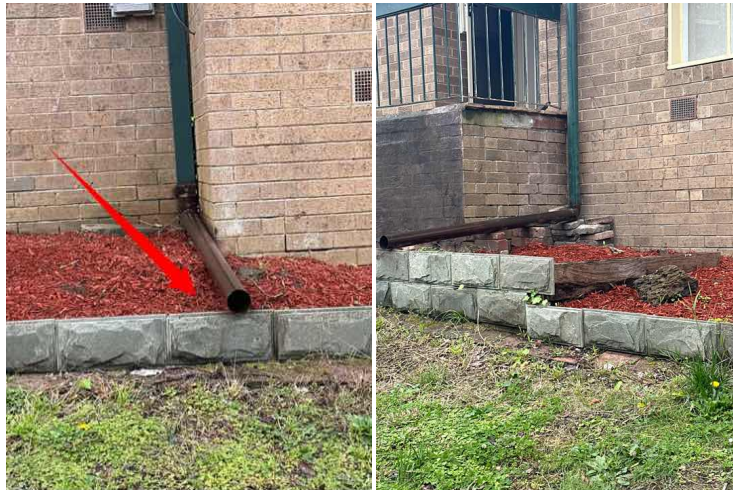
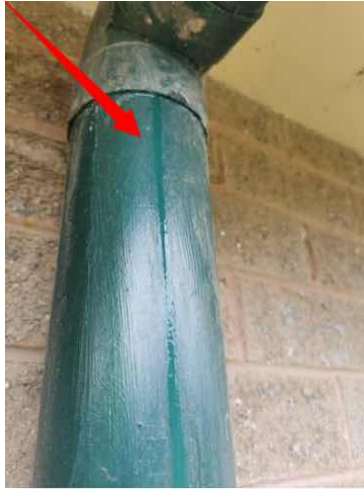
Leaking downpipe joints visible. This can be conducive to termite infestation and cause water damage to cladding over time. A qualified roof plumber should be engaged to repair.

Downpipe/s not connected to storm water discharge - Downpipes not connected to storm water have the potential to cause differential settlement to the footings, cause rising damp and is also conducive to termite infestation. A qualified roof plumber should be engaged for advice and recommendations.

Spreado not installed

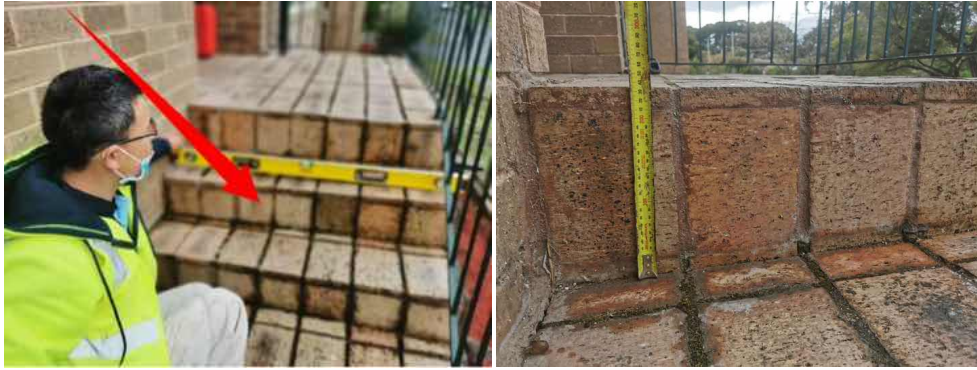
The entry porch serviceable or in reasonable or condition for the age of this dwelling.  
The stair not compliance

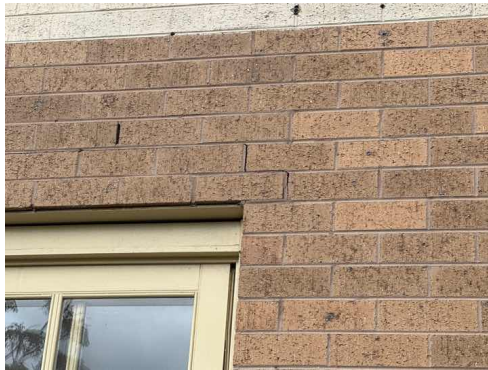
There appears to have been some settlement in the building which has caused some cracking to the walls. These cracks are categorized as 0 to 2. This can also cause some doors to bind or be out of square. In the inspectors opinion these cracks are due to settlement, usually due to ground movement and subsequent movement to building materials can be expected. Any cracks should be monitored and if cracks increase in size, further investigation should be carried out by a structural engineer.

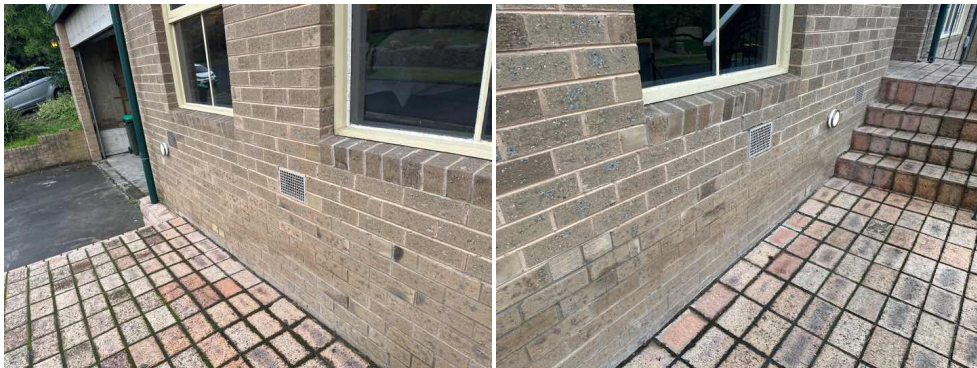
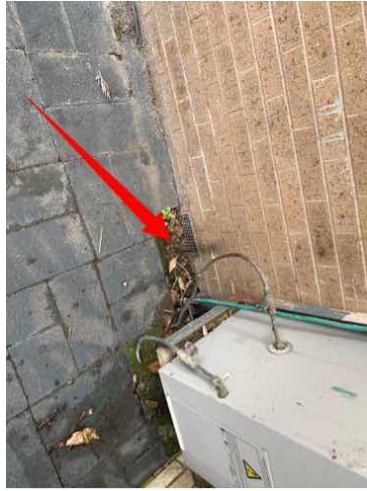
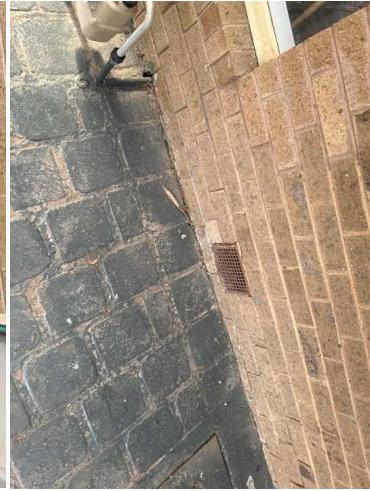
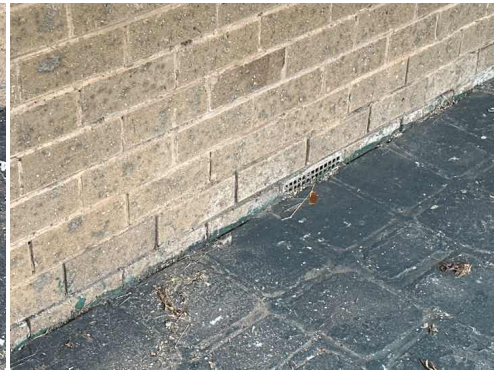
Vents are covered by soil/vegetation or have debris restricting ventilation to the sub floor Recommendations: Remove vegetation and or lower soil levels so that sub floor vents are unobstructed and allowing free flowing air.

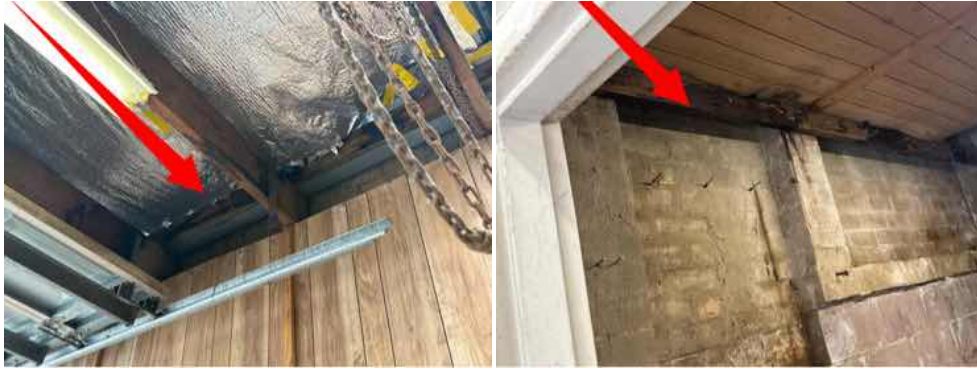
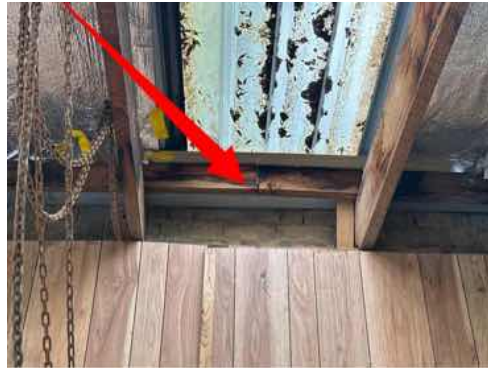
Ceiling stains - Moisture readings obtained - Possibly still active leaking. A qualified roofer/roofing plumber should be engaged for advice and recommendations. I strongly recommend that all water damaged plaster replaced by a qualified plasterer due to potential detachment or collapse.

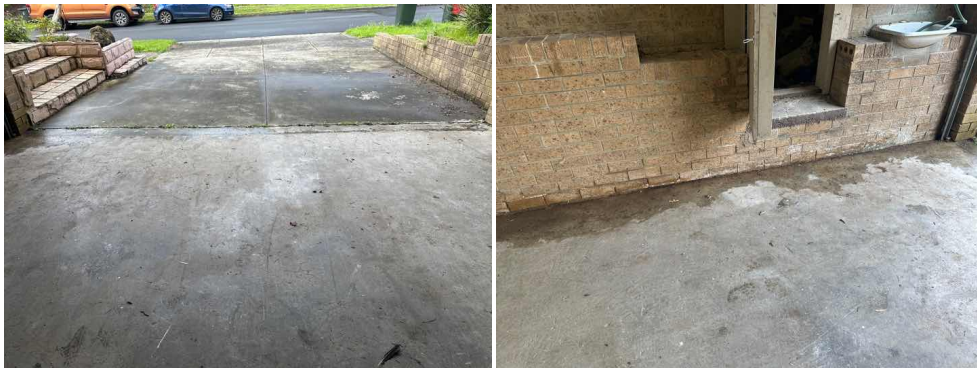
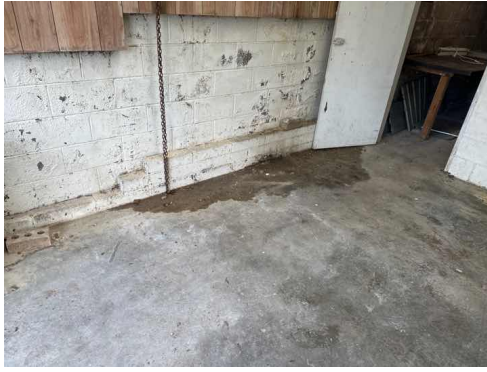
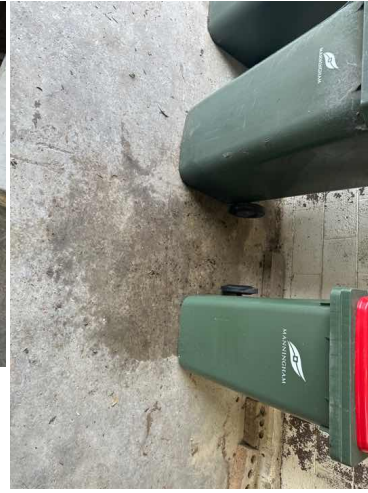
Water appears to have penetrated via the door. Drainage may be required. Recommendations: A qualified plumber should be engaged for advice and recommendations.

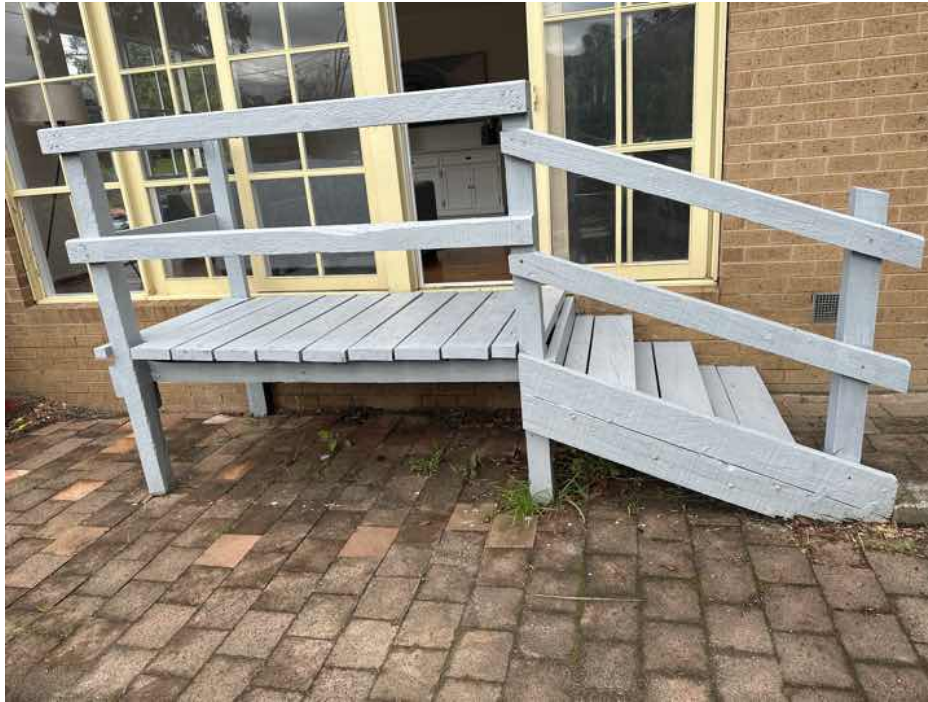
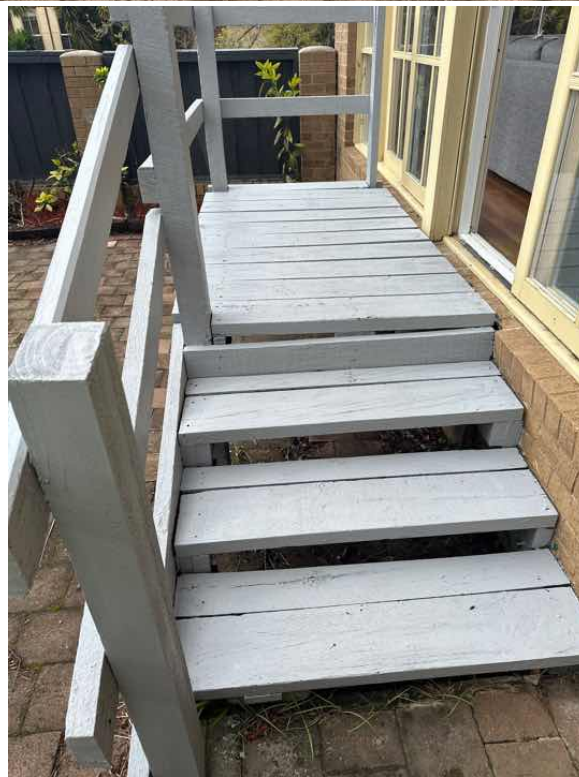
Poorly constructed. Check with council regarding legality.

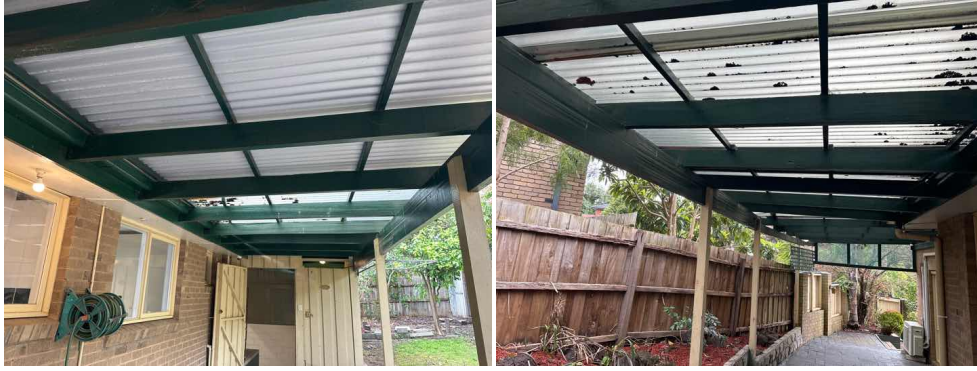
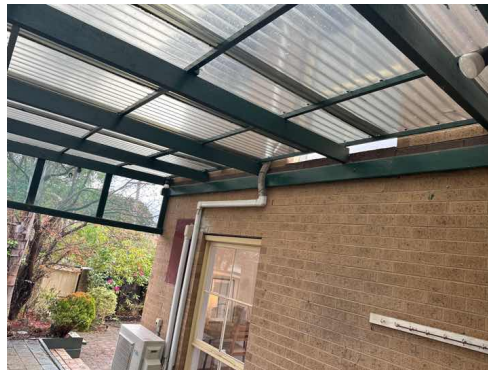
### Poor Check Legal

Poorly constructed . Check with council regarding legality.

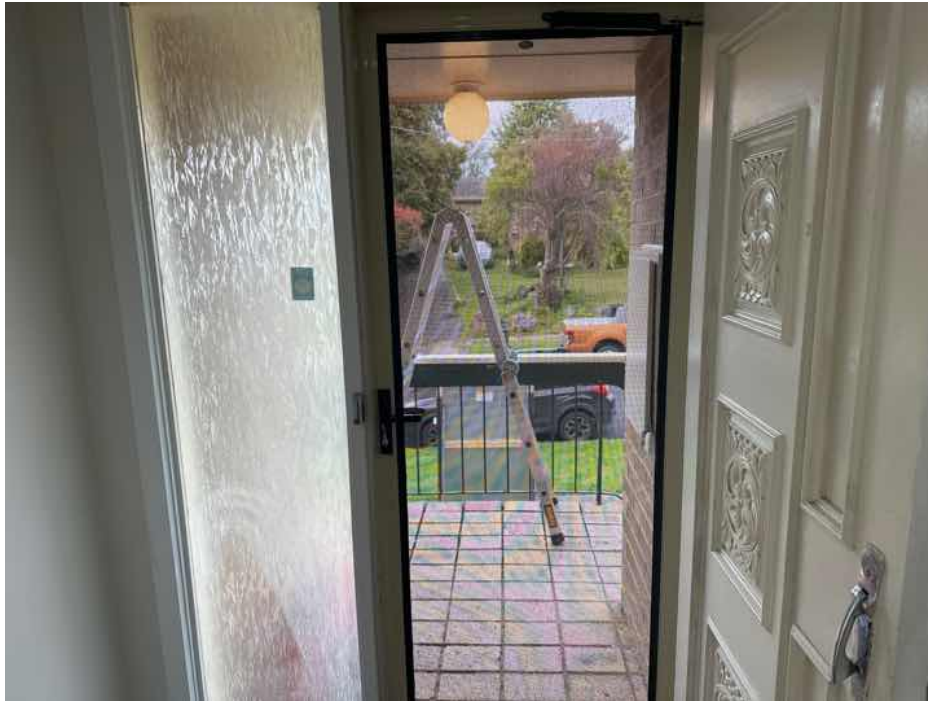
### Front Entry Doors

The doors are in serviceable condition with no notable defects observed.

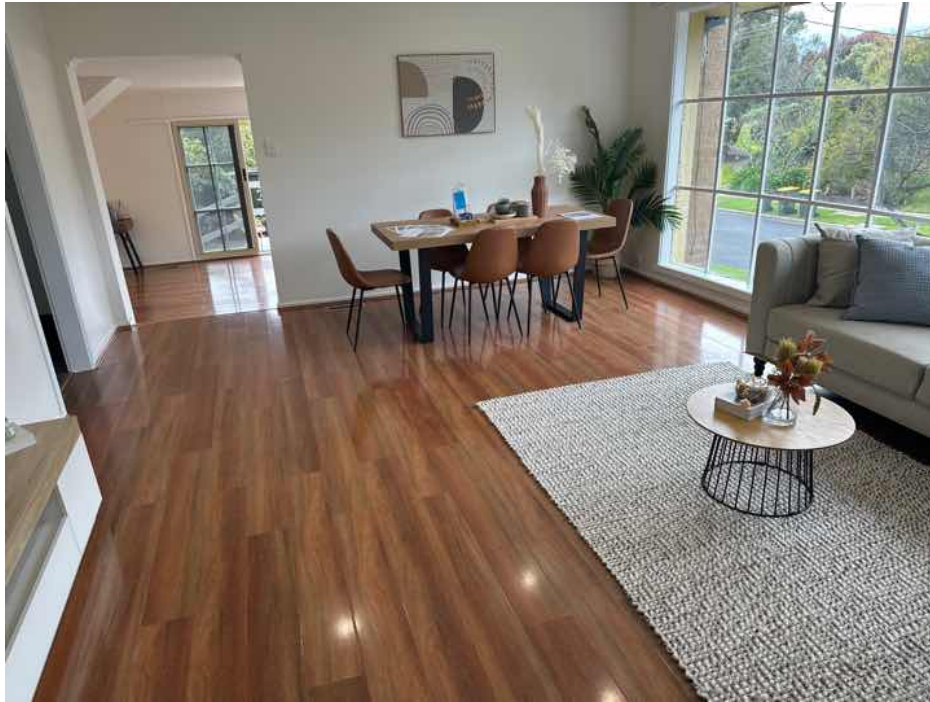
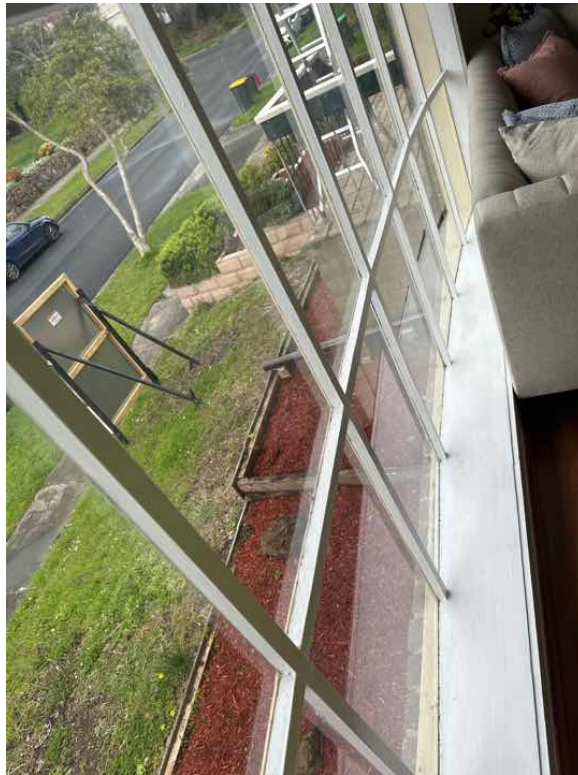
## Living Room

From the visible and accessible areas, this room appears to be in a serviceable condition for the age of the property with no notable structural defects sighted.

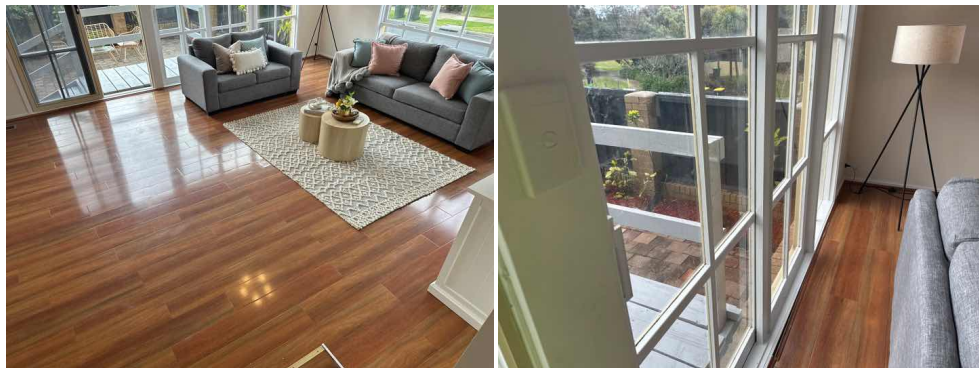
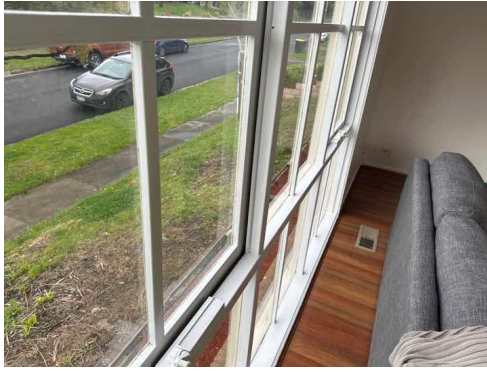
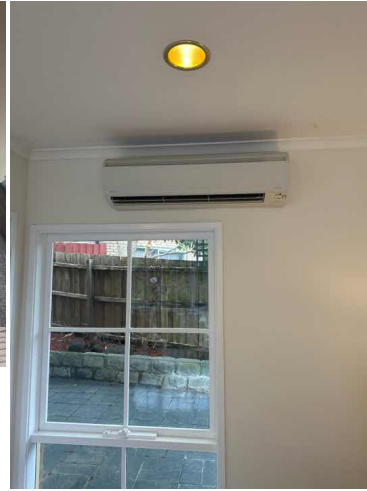
## Combined Living & Dining

From the visible and accessible areas, this room appears to be in a serviceable condition for the age of the property with no notable structural defects sighted.

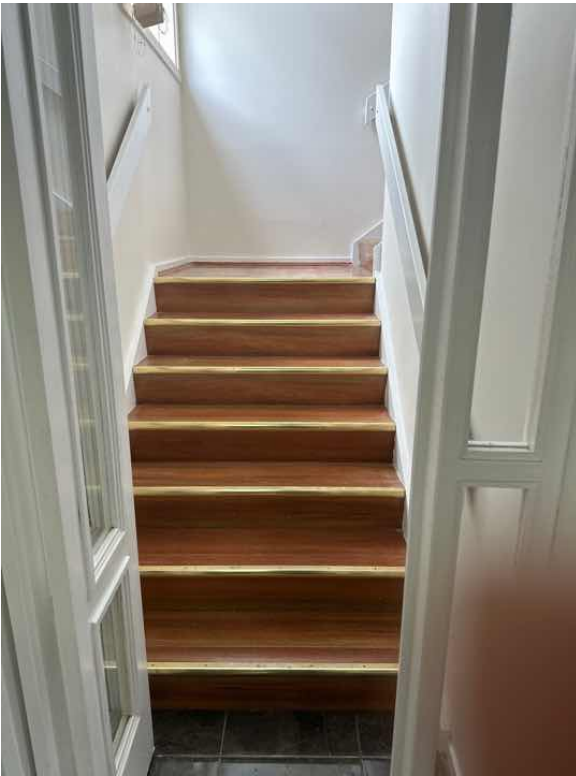
## **Internal Stair Case**

The internal staircase and components appear to be in a serviceable condition for the age with no notable defects sighted.

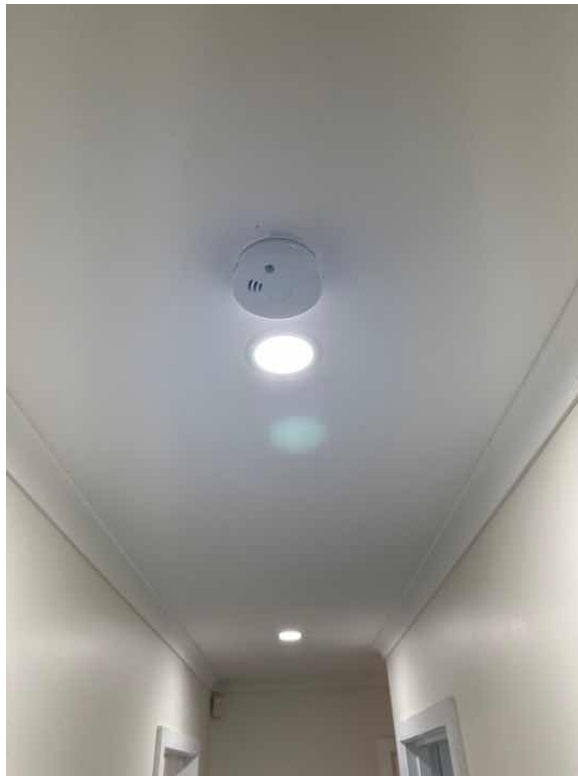
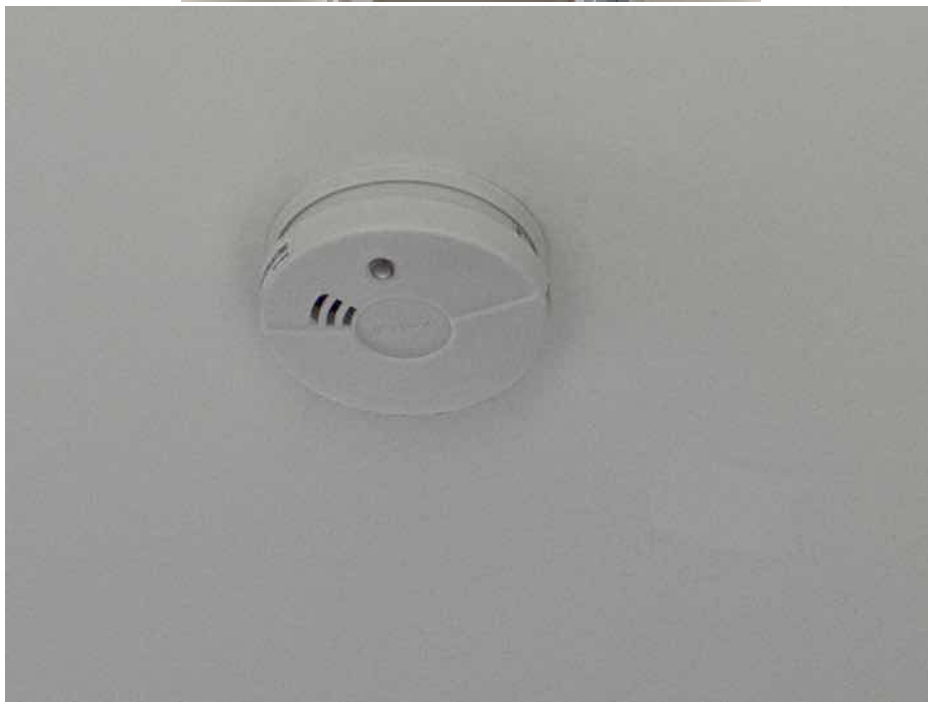
## **Smoke Alarm**

It appears serviceable condition at the time of inspection

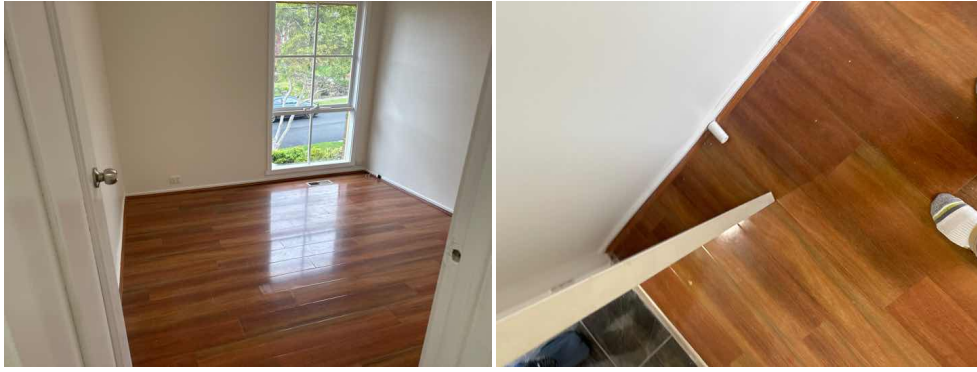
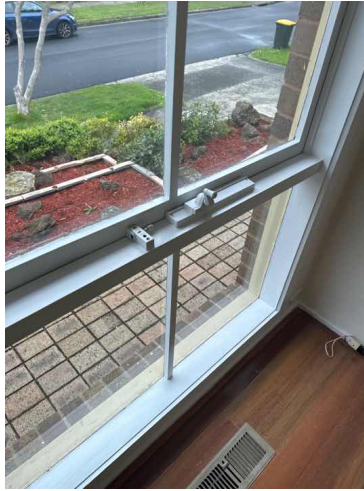
## **Bedroom 1**

From the visible and accessible areas, this bedroom appears to be in a serviceable condition for the age of the property with no notable structural defects sighted.

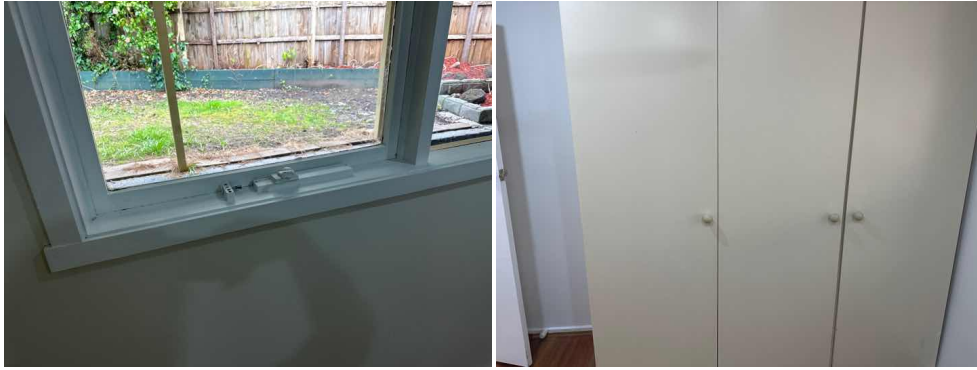
## **Bedroom 2**

From the visible and accessible areas, this bedroom appears to be in a serviceable condition for the age of the property with no notable structural defects sighted.

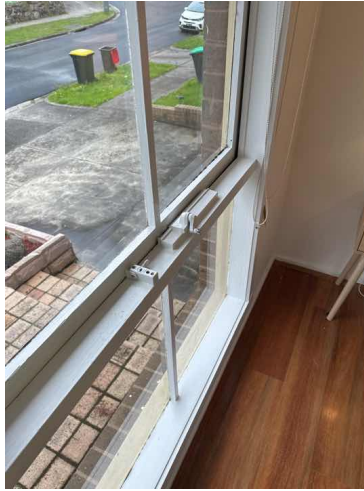
### **Bedroom 3**

From the visible and accessible areas, this bedroom appears to be in a serviceable condition for the age of the property with no notable structural defects sighted.

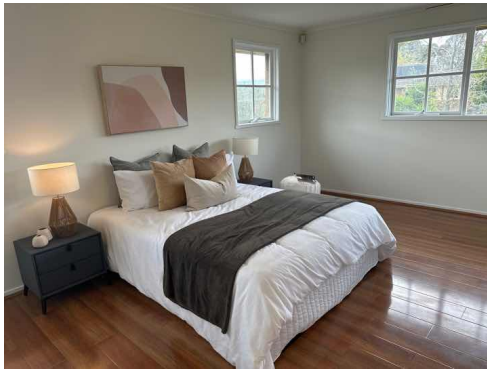
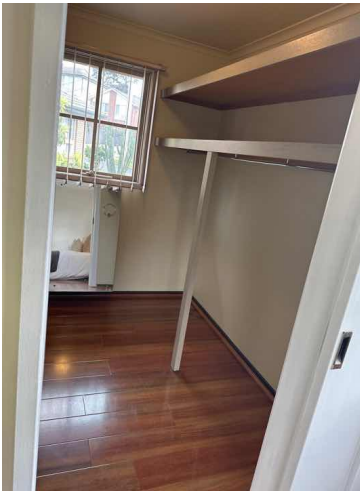
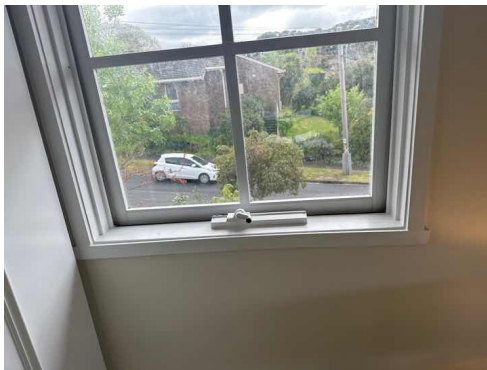
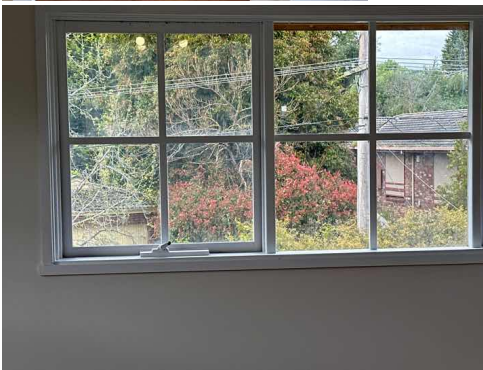
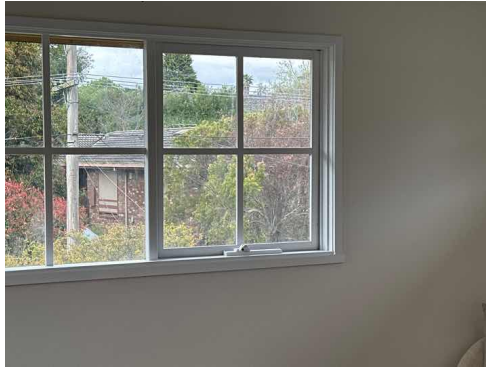
## **Bedroom 4**

From the visible and accessible areas, this bedroom appears to be in a serviceable condition for the age of the property with no notable structural defects sighted.

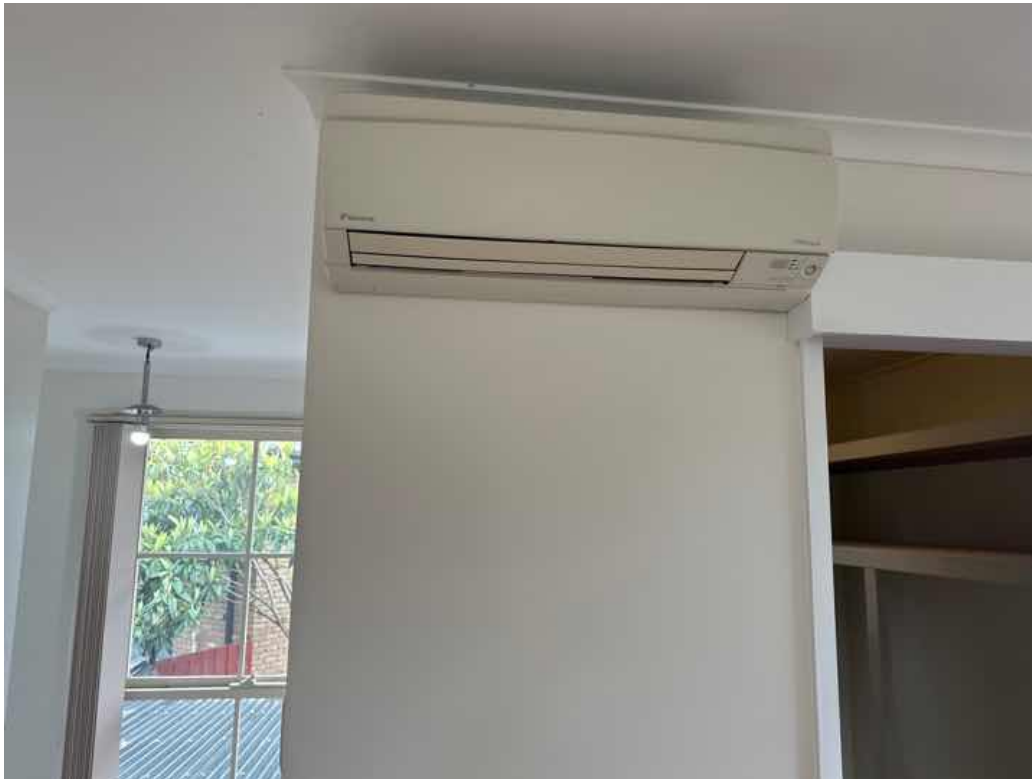
## **Air Condition**

The air condition is serviceable at the time of inspection.

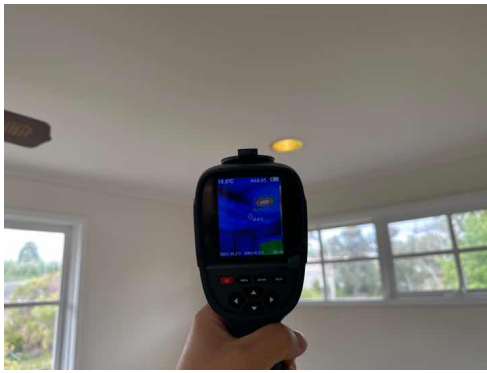
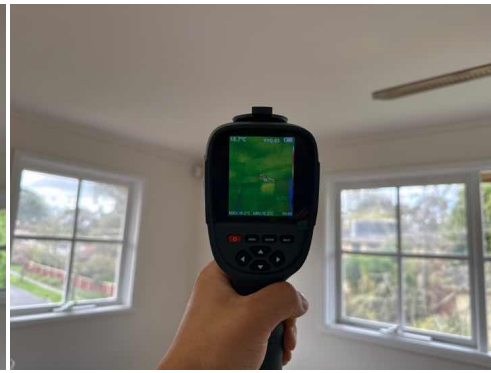
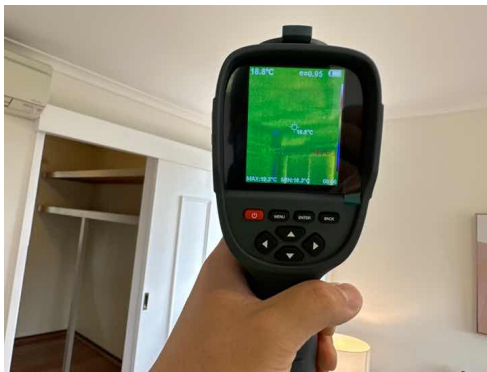
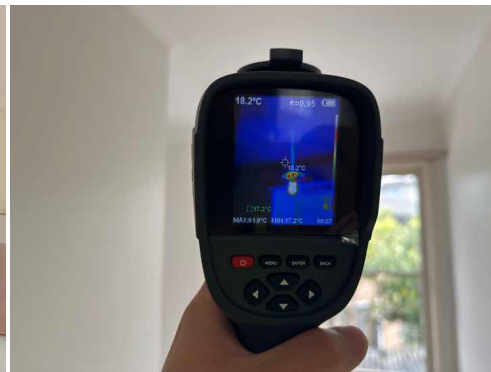
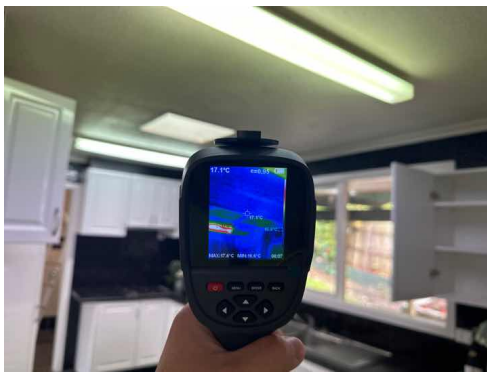
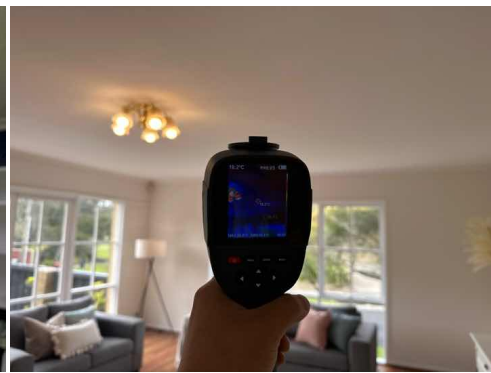
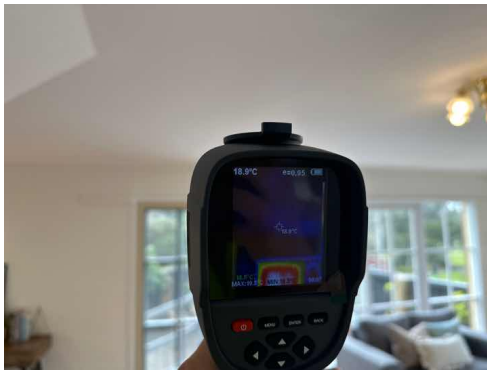
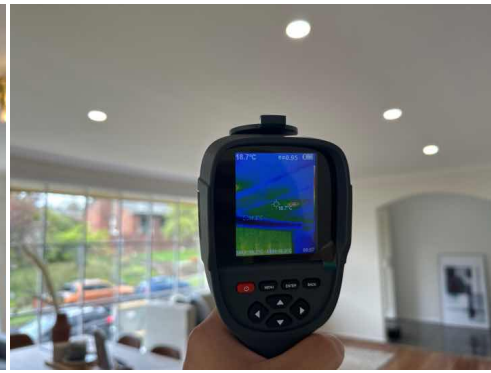
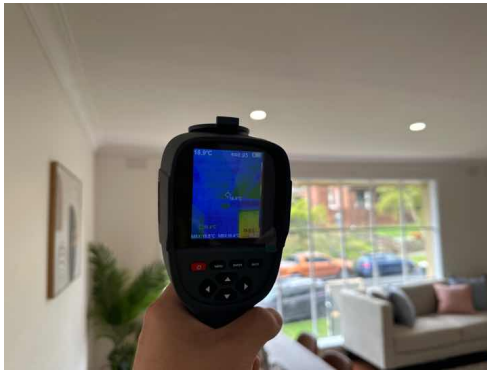
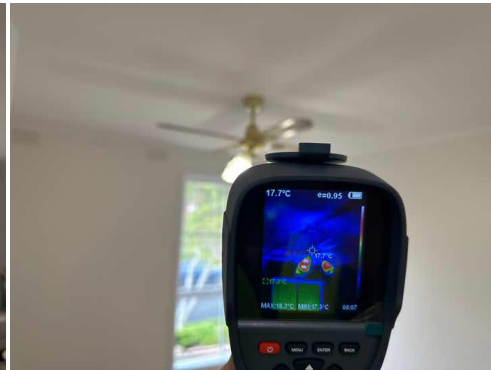
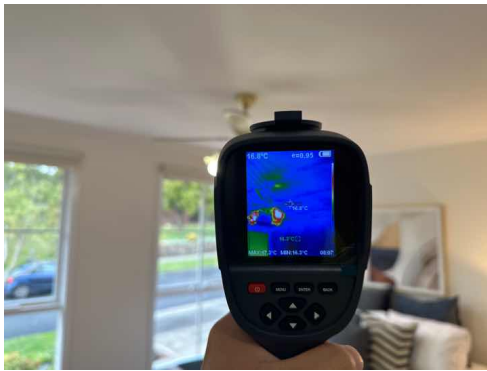
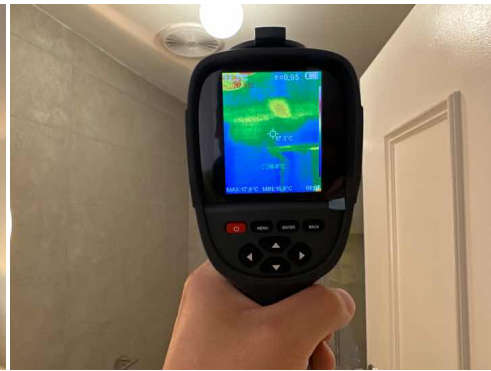
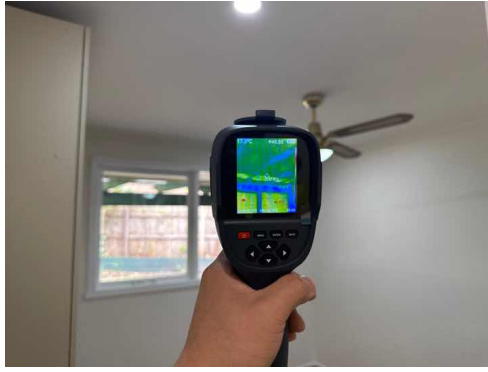
### **Thermal Image Camera Check**

Thermal image camera temperature reading normal.

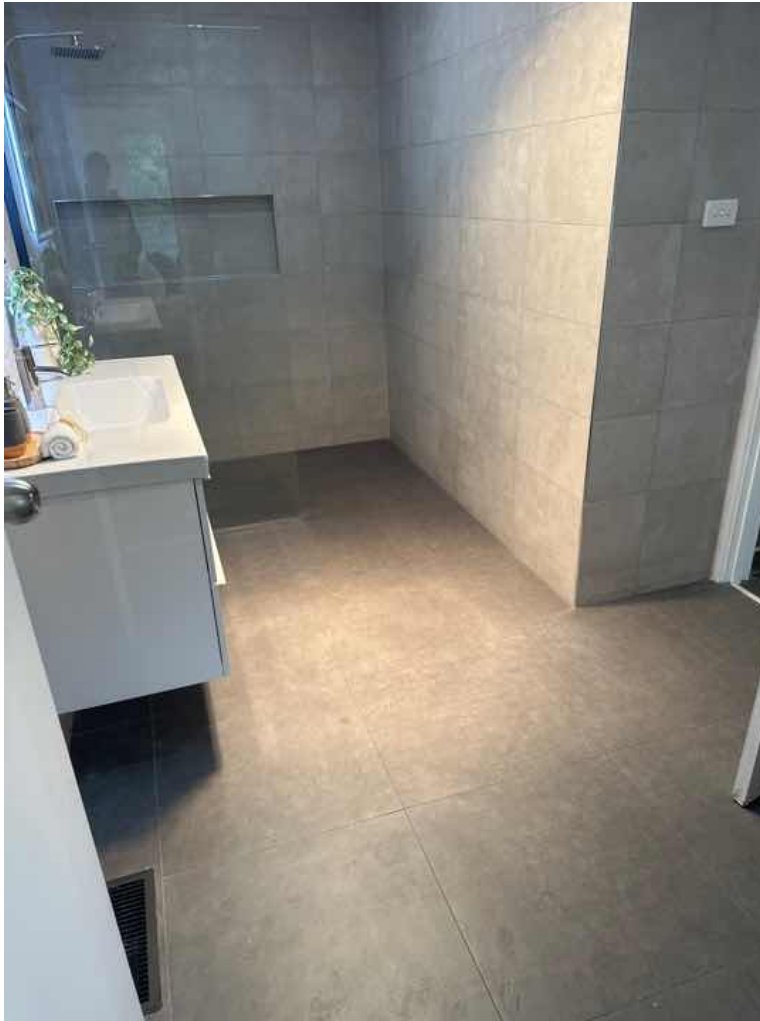
### Location

This bathroom is located in the lower level.

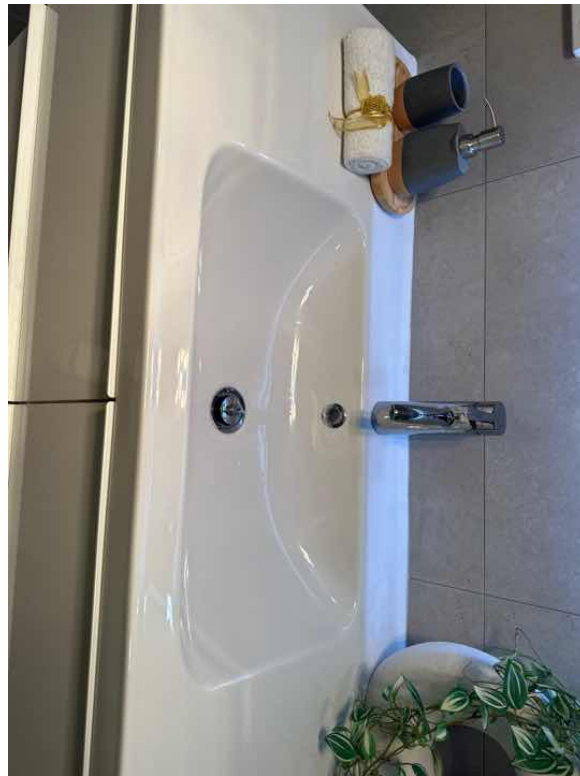
The sink is in serviceable condition with no not defects observed.

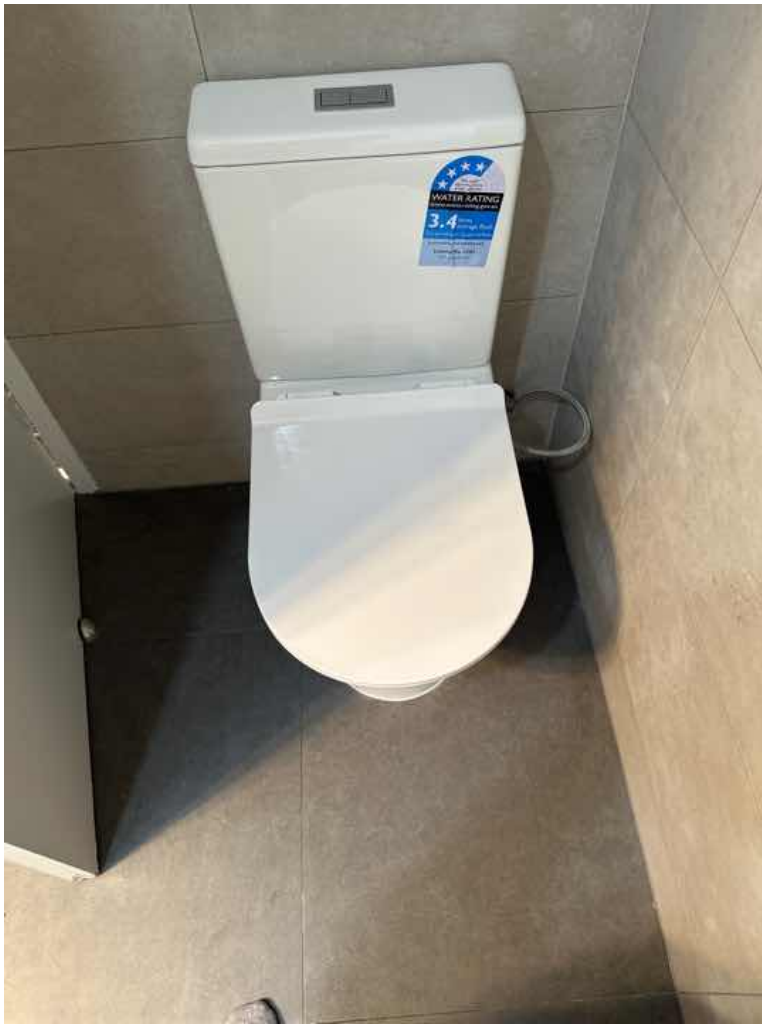
The toilet is in a serviceable condition

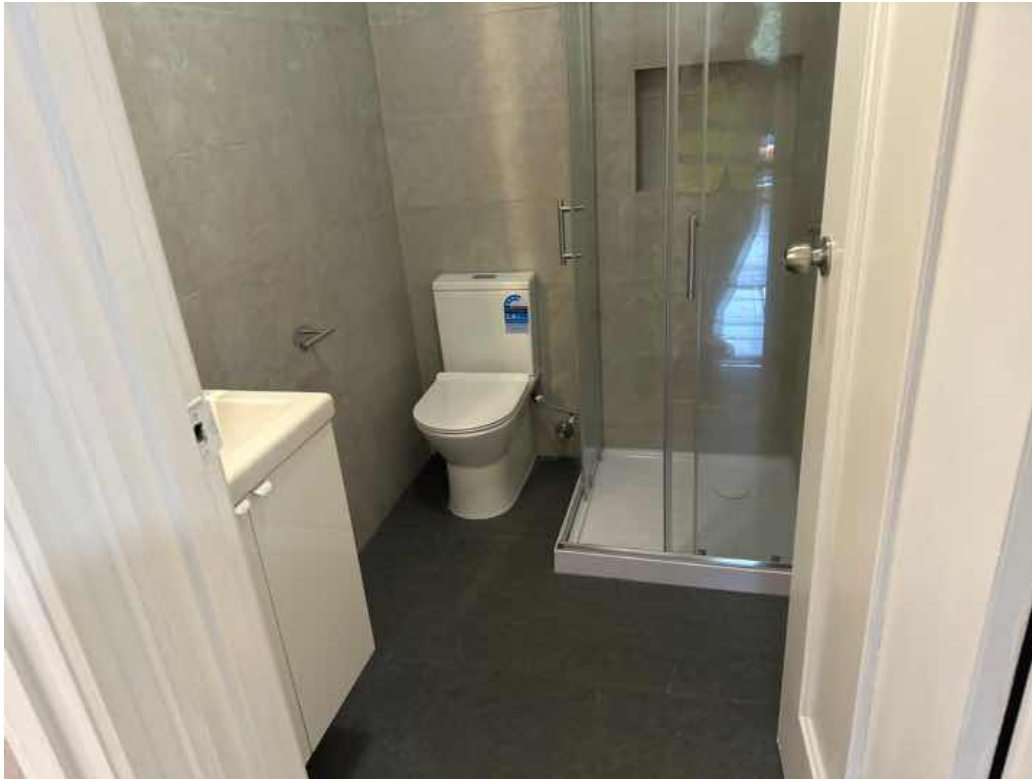
This bathroom is located in the lower level.

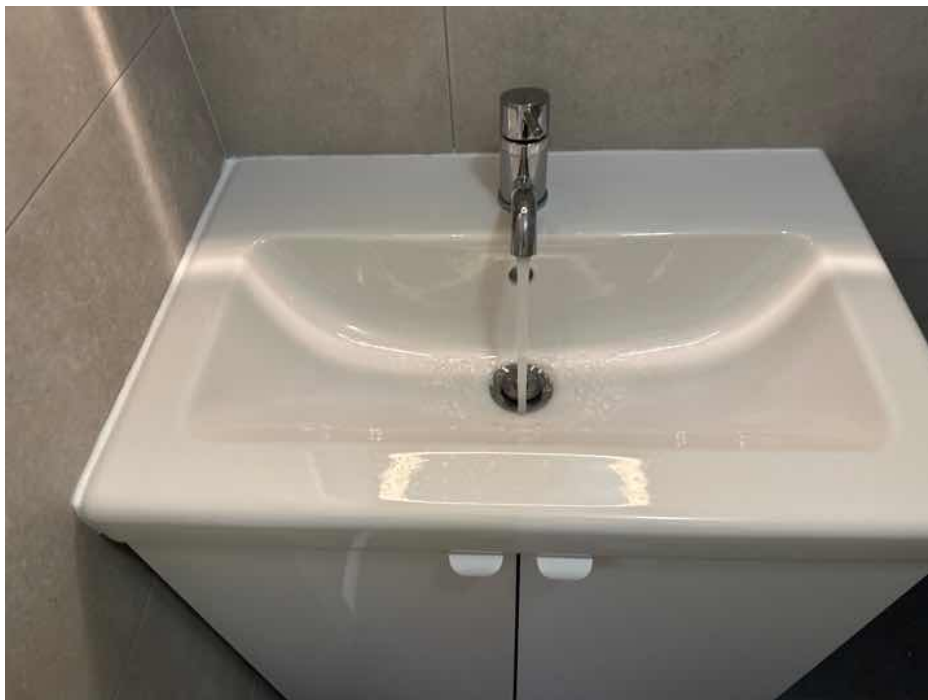
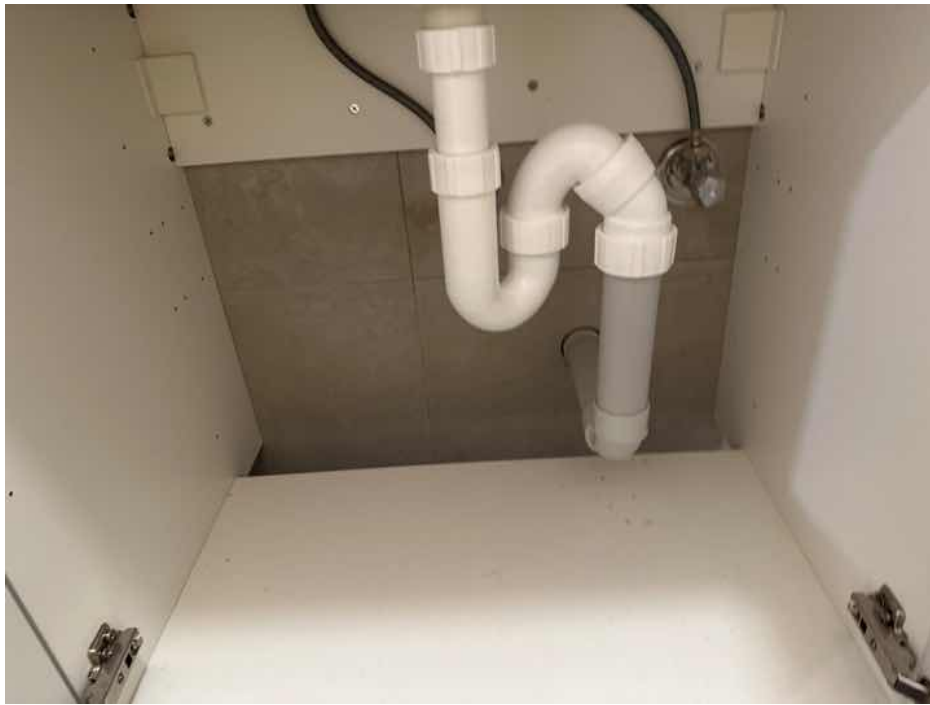
The sink is in serviceable condition with no not defects observed.

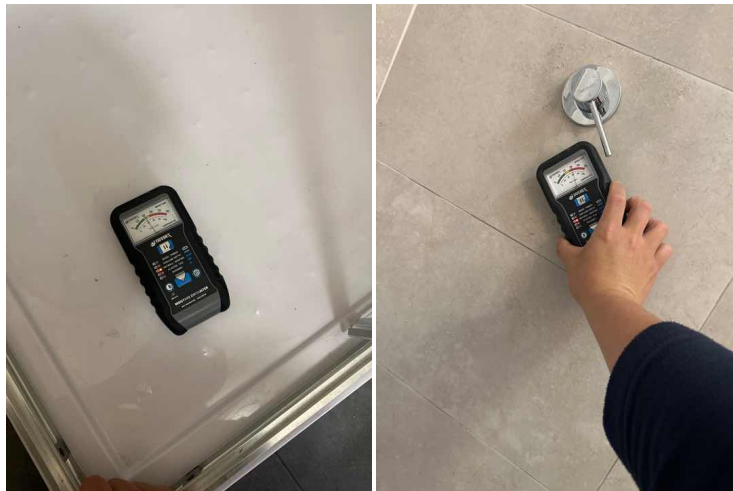
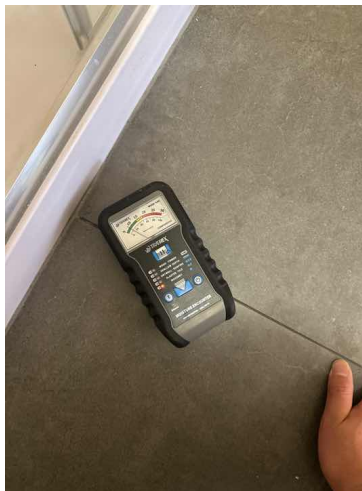
The shower is in serviceable condition with no not defects observed.

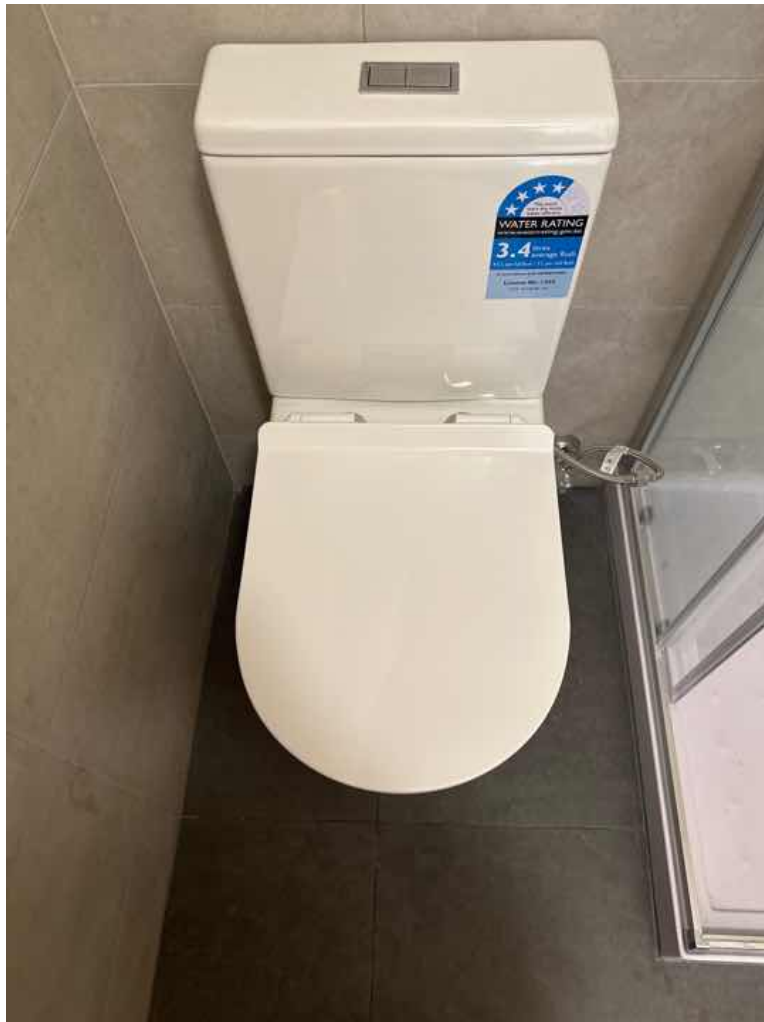
The toilet is in a serviceable condition

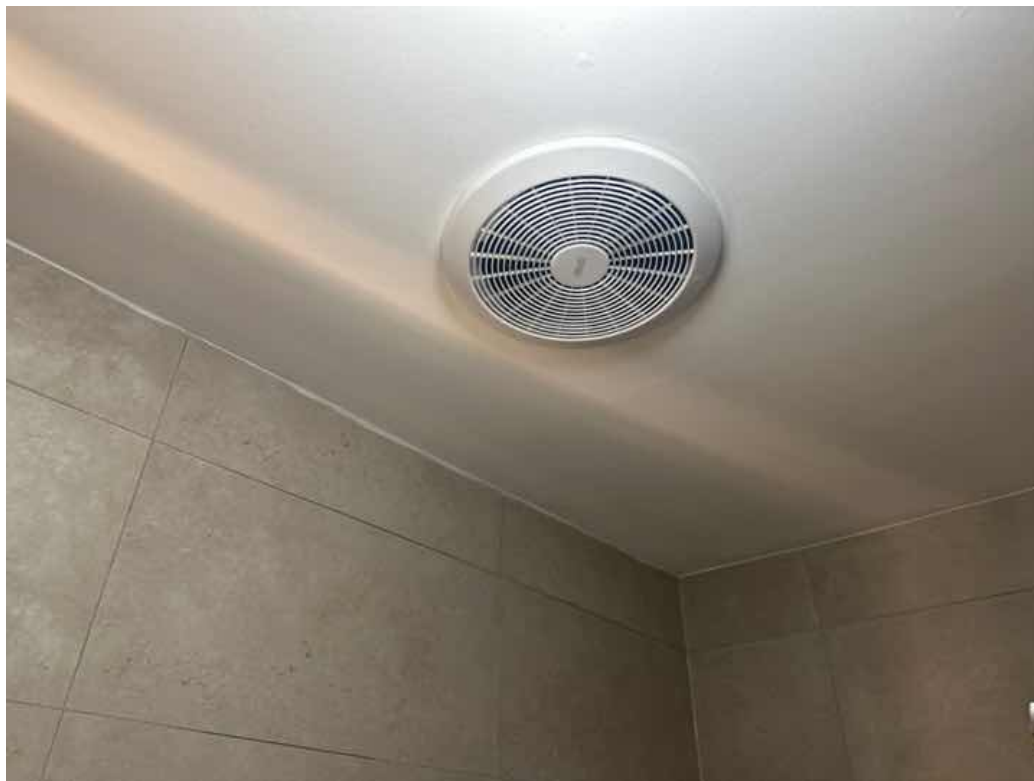
The vent is serviceable at the time of inspection.
