# Inspection Report

**A Plus House Inspection**

Report/Agreement # 061022095962

Inspection Date: 06 Oct 2022

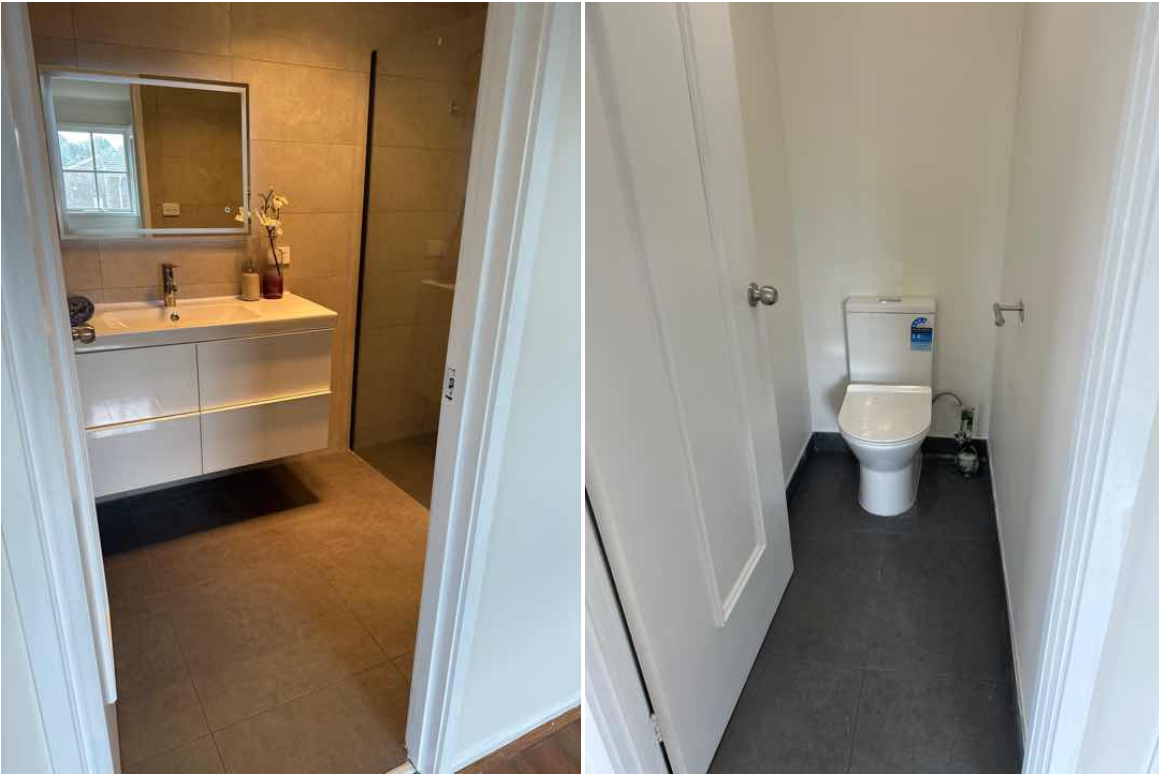
This bathroom is located in the master bedroom.

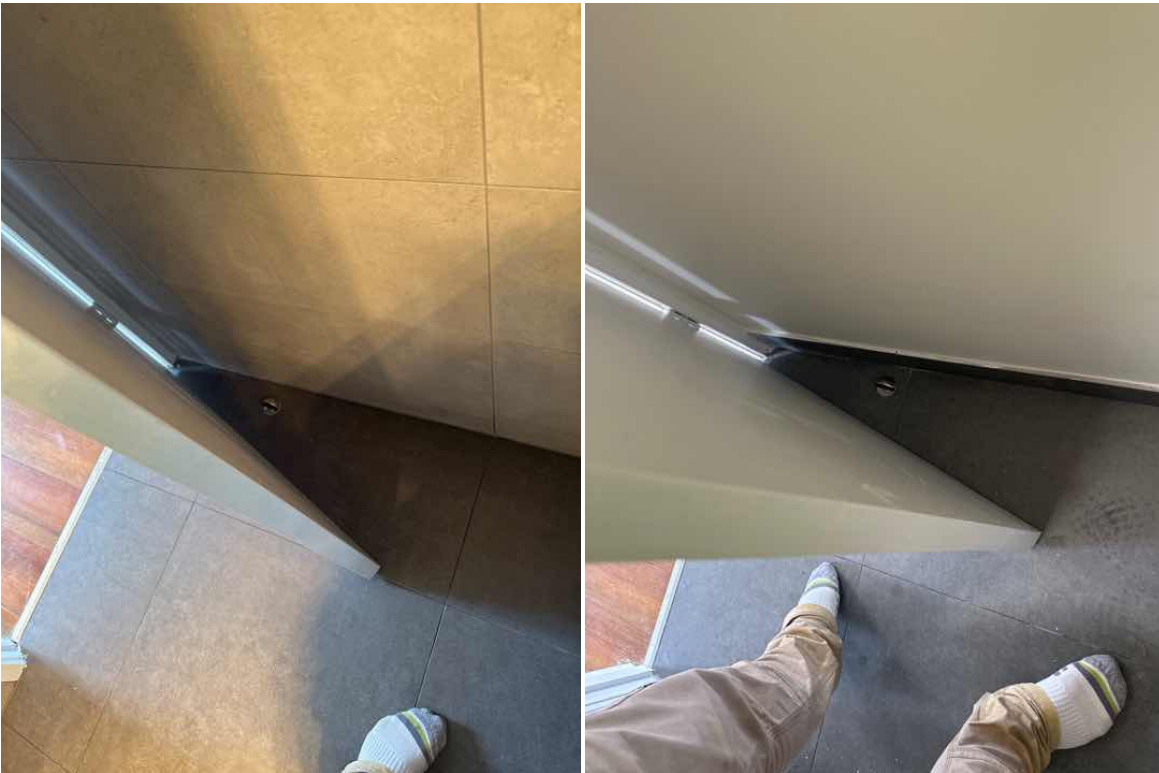
The door is in serviceable condition with no not defects observed.

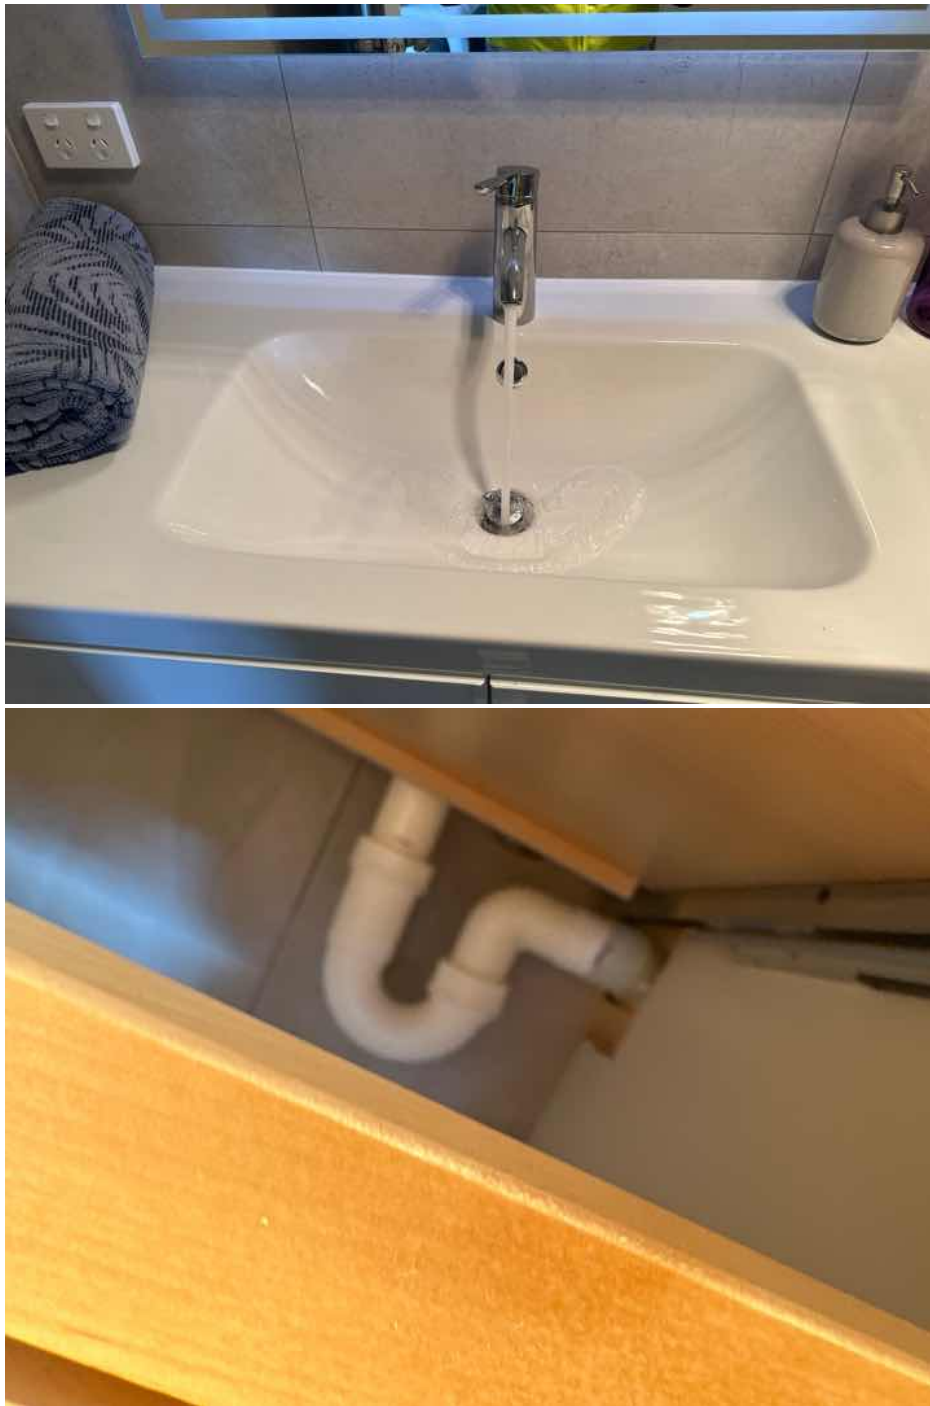
The sink is in serviceable condition with no not defects observed.

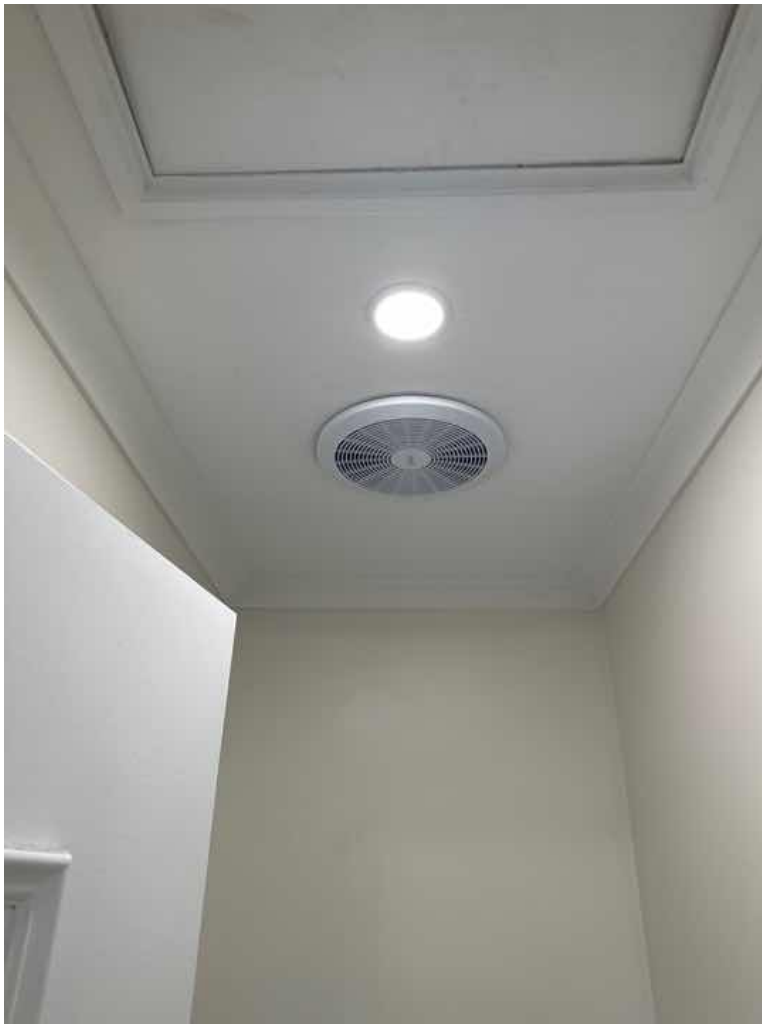
The vent is serviceable at the time of inspection.

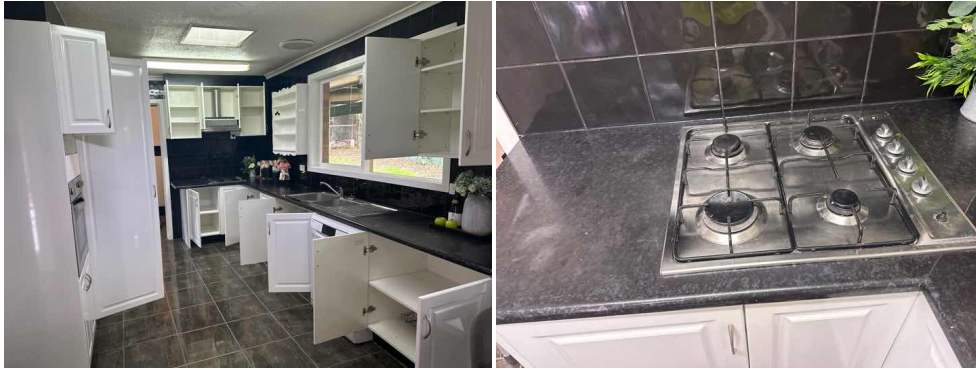
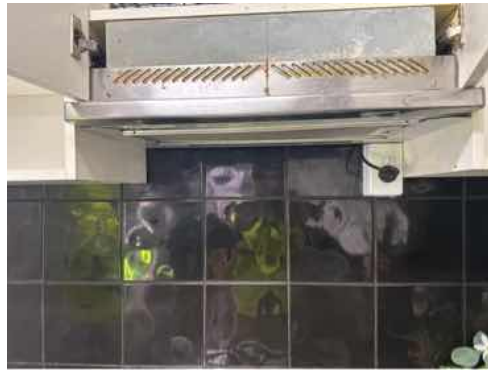
Of the visible areas, the general condition of the kitchen and pantry is serviceable or in reasonable condition for age of dwelling.

Rangewood not work.

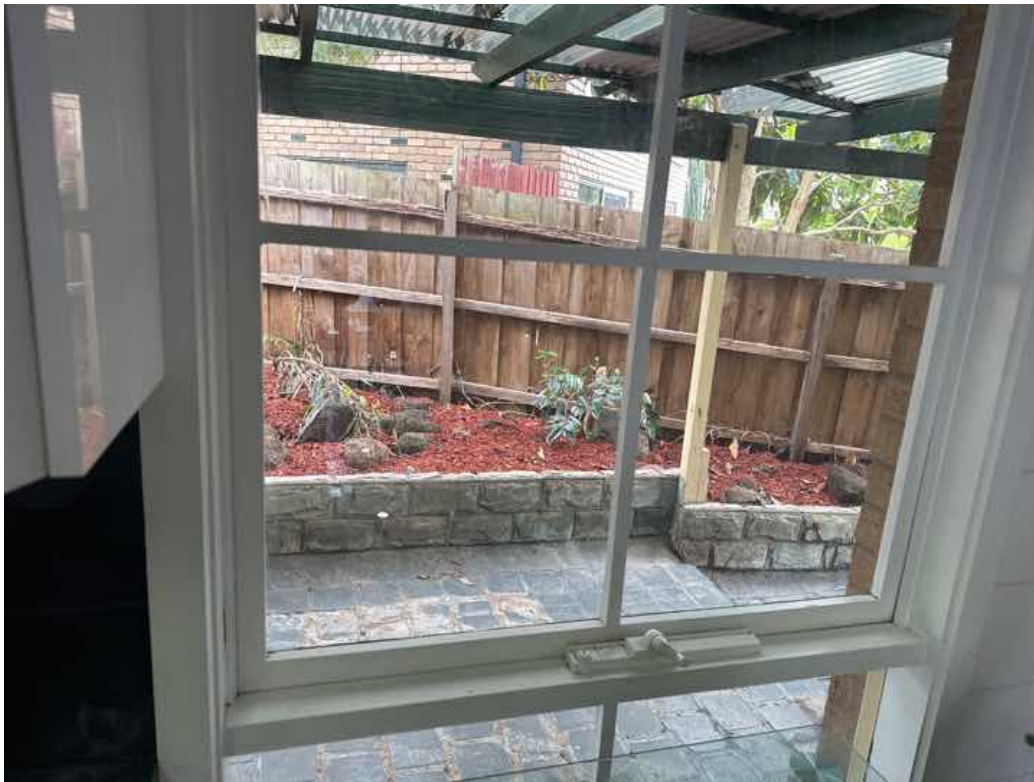
The window is in serviceable condition with no not defects observed.

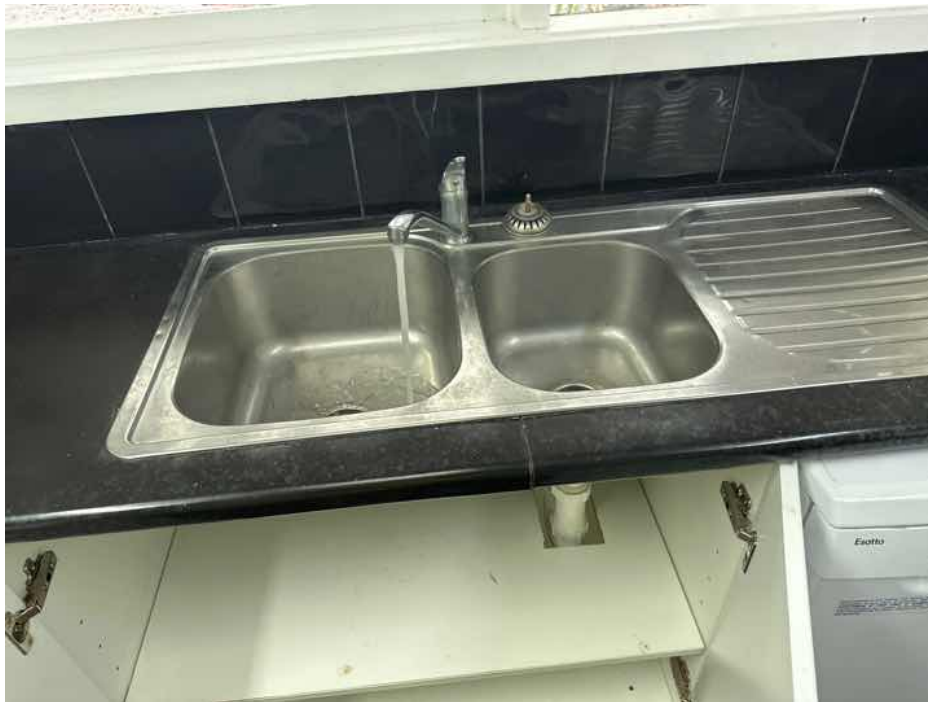
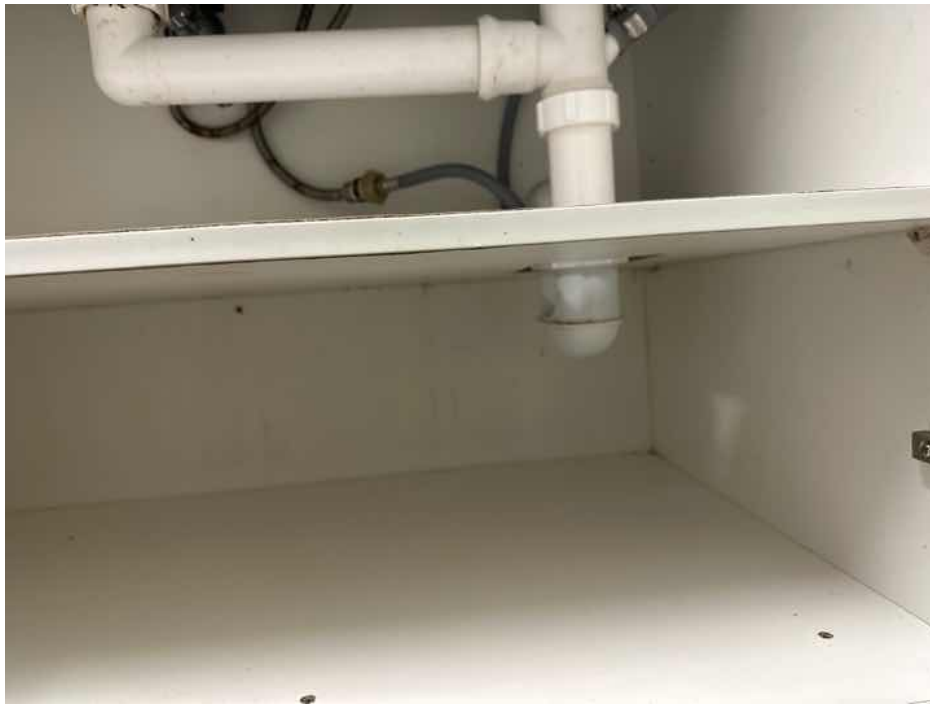
The sink appears serviceable condition at the time of inspection.

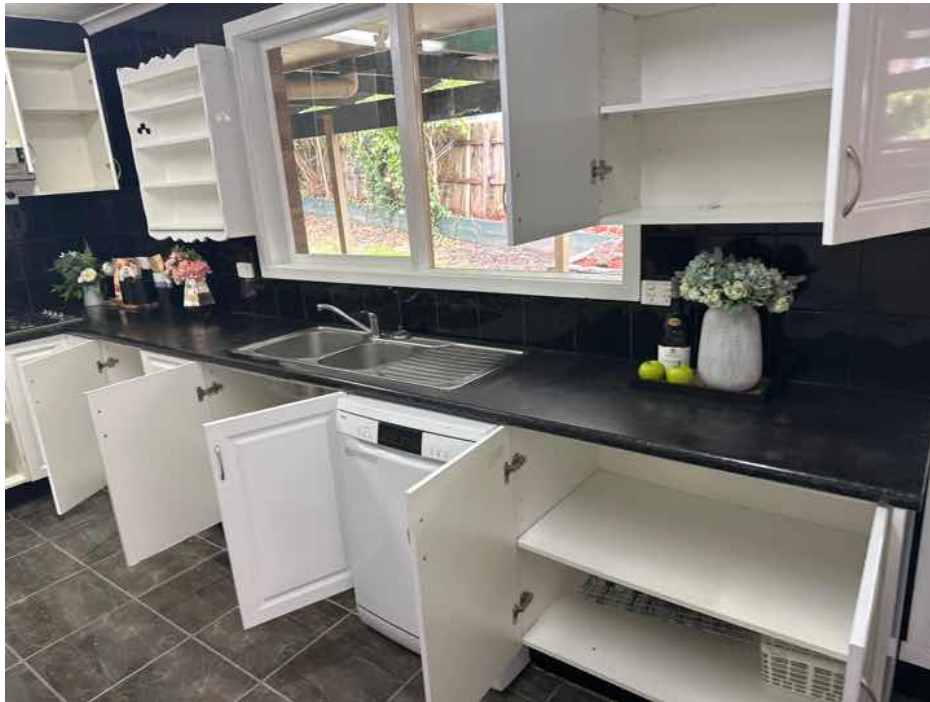
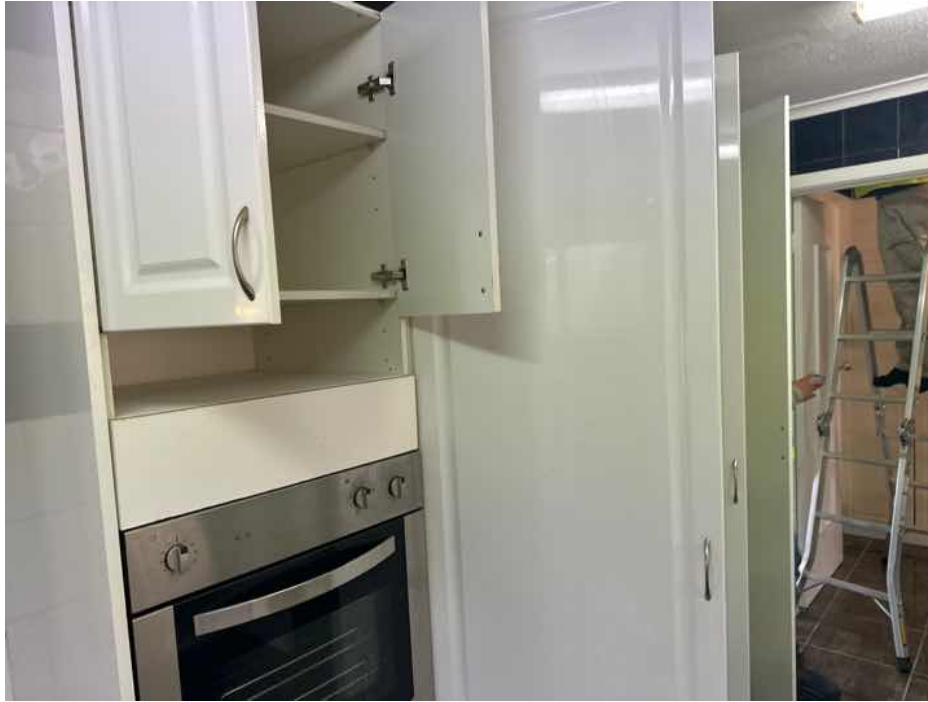
These components appear to be in a serviceable condition

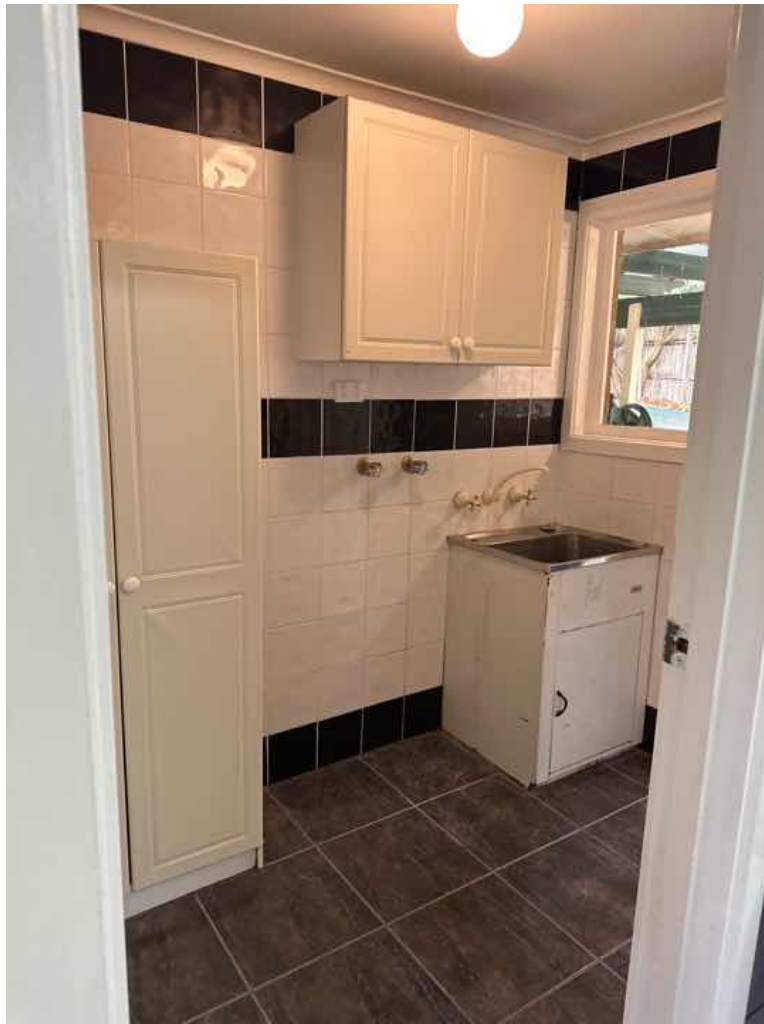
Of the visible areas, the general condition of the laundry is serviceable or in reasonable condition for age of dwelling.

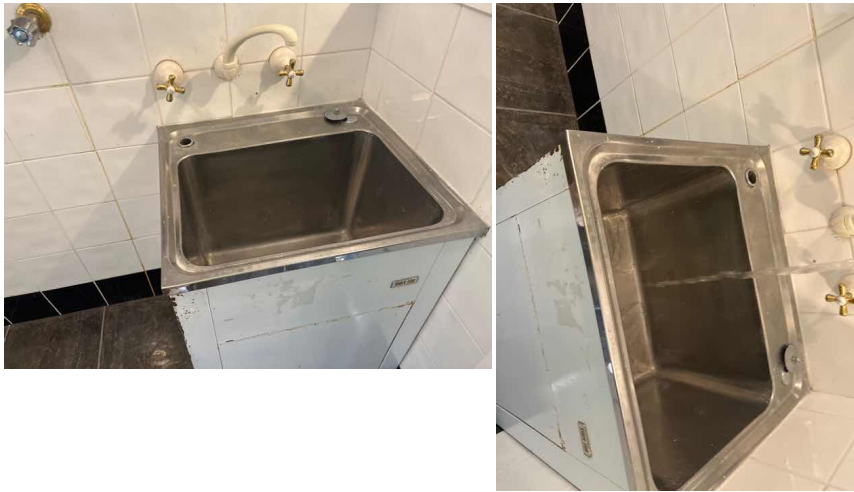
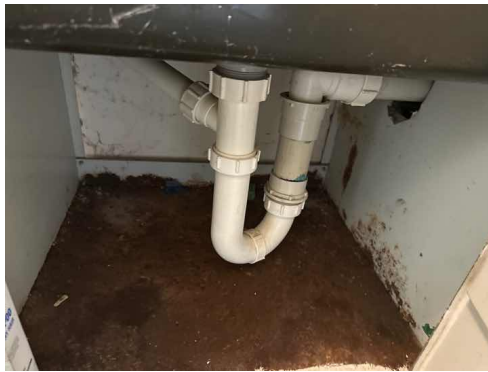
The tap and sink are in serviceable condition with no not defects observed.

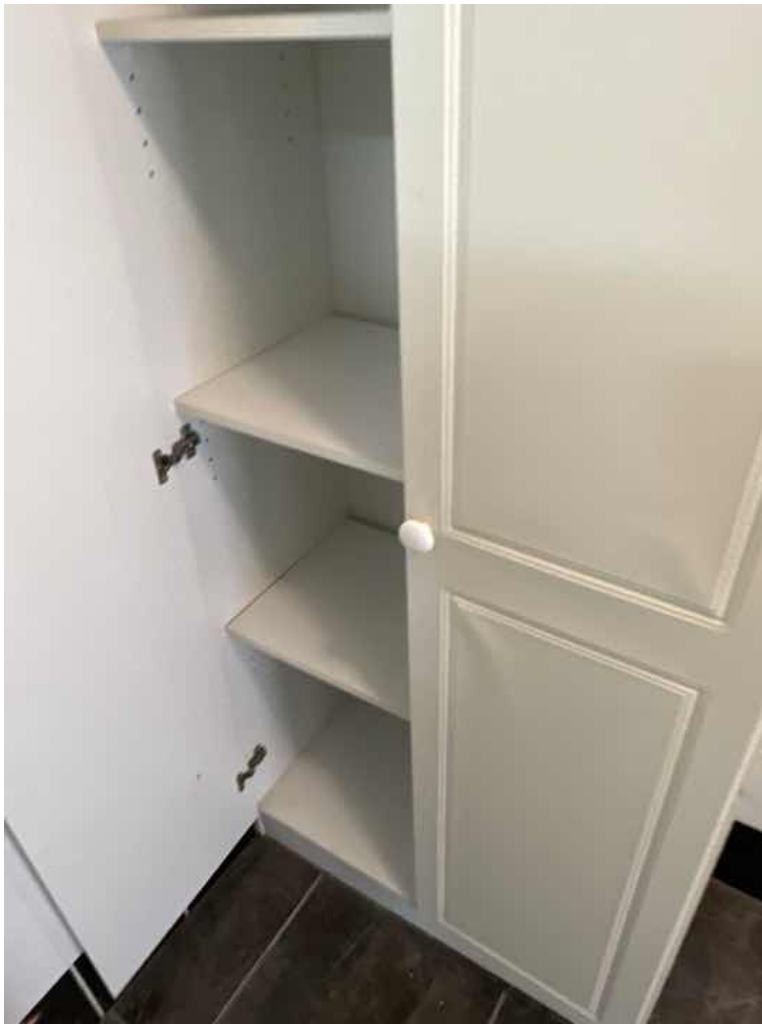
These components appear to be in a serviceable condition

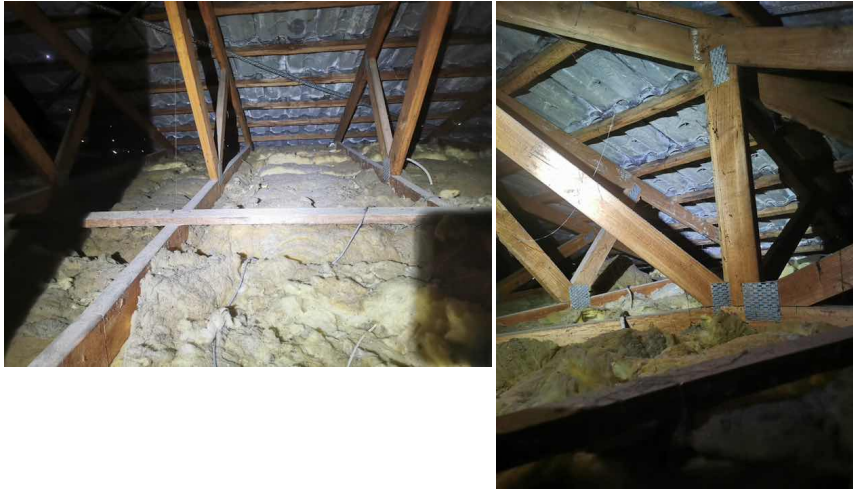
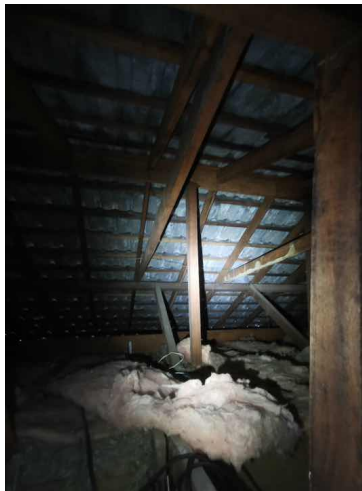
The roof space is insulated with fibreglass batts.

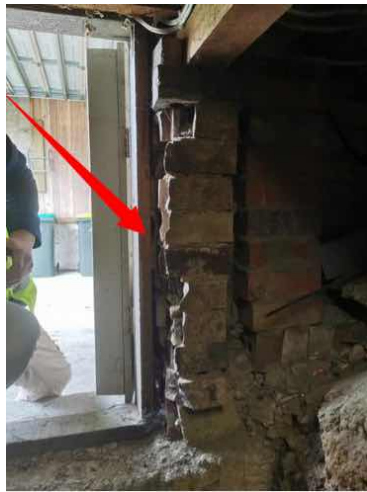
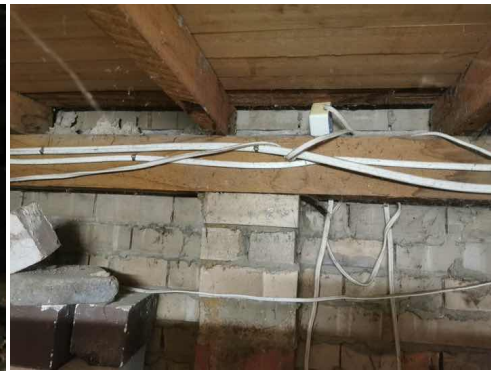
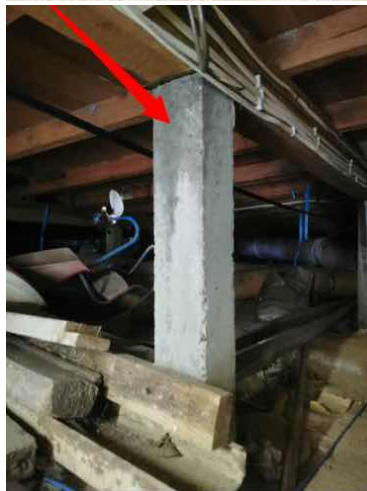
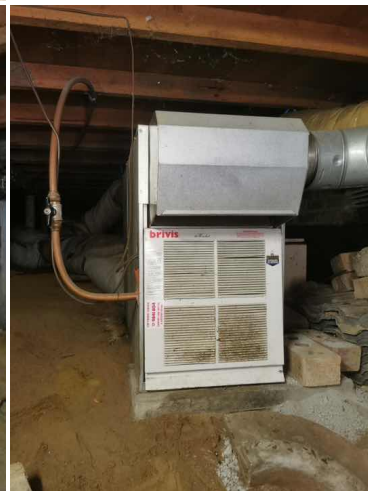
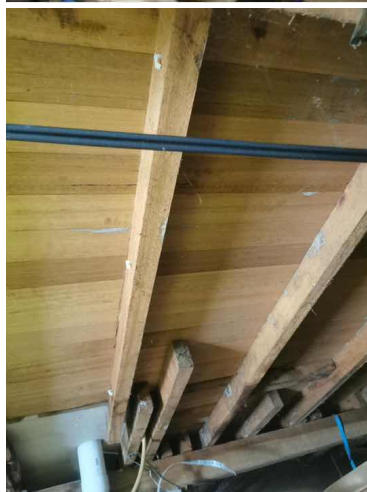
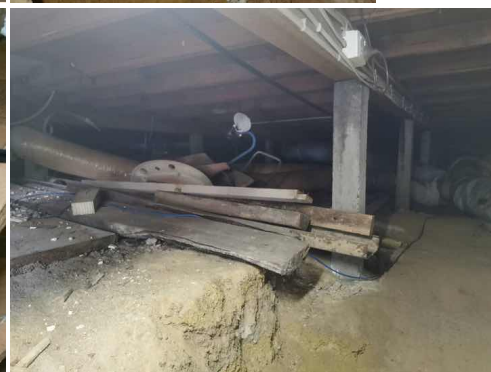
Ant caps are either missing or not installed. The purpose of ant capping is to prevent concealed termite entry by forcing the termites build mud tunnels around the visible sections of the ant capping enabling detection during a pest inspection. Ant caps will not prevent the entry of termites to a structure however, correctly fitted ant caps will assist in early detection.

Make shift brick piers have been constructed without footings in an attempt to add support. Contact a brick layer for further advice.
